Identifying Stormwater Sources of Microbial Contamination at Bruce Beach, Pensacola, FL

Technical Report to City of Pensacola

July 29, 2022

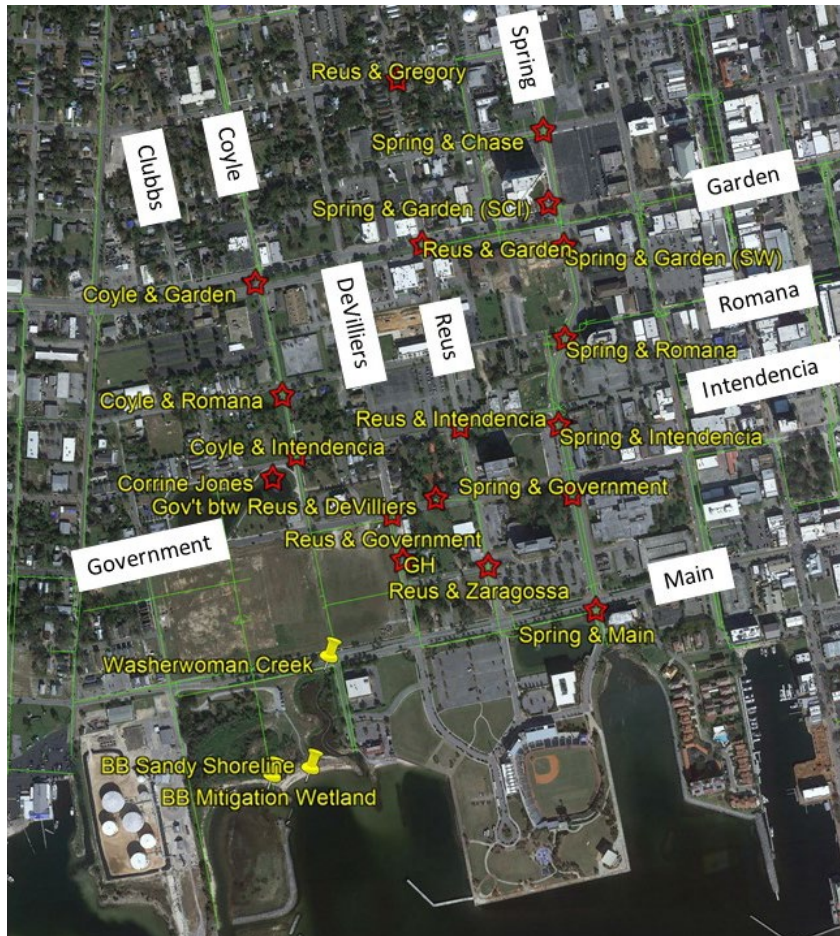
Figure 3 - Downtown Pensacola showing stormwater pipes in green and BFA/UWF sampling locations in stormwater inlets as red stars and Bruce Beach sampling locations as yellow pins.

The City of Pensacola and ECUA provided maps of the subsurface infrastructures (stormwater and sewage) (Fig. 3). To understand potential bacterial sources to Washerwoman Creek and the Bruce Beach area, stormwater inlets upgradient of Bruce Beach were sampled. Sampling design and strategies were based on the street grid pattern and a feedback loop. Stations that samples with *Enterococcus* concentrations less than the 70 MPN/100 mL threshold within 48 hours after a rain event were not resampled. The inlets varied from shallow street-level inlets (Figure 4) to remnants of deeper brick-lined circular, square, or rectangular shaped wells (3-feet, 5-feet, and

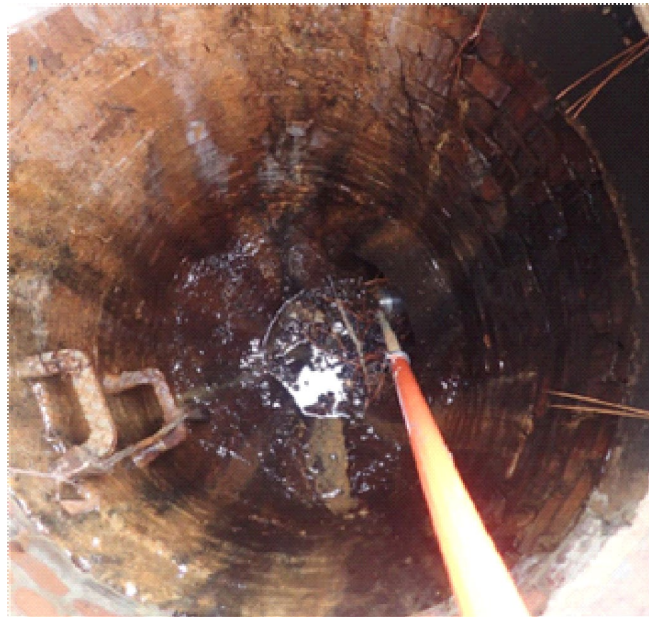
Figure 5- Deep stormwater outfall showing groundwater seeps entering through the joints between bricks (seen as darker streaks)

upwards of 10-feet deep) which serve to consolidate stormwater from other nearby inlets (Figure 4). The older, aged stormwater inlets were often observed to have seepages or infiltration of groundwater through cracks in the conveyance structure or most often, where the grout between bricks have worn away and offered easy access for groundwater infiltration (Figure 5).

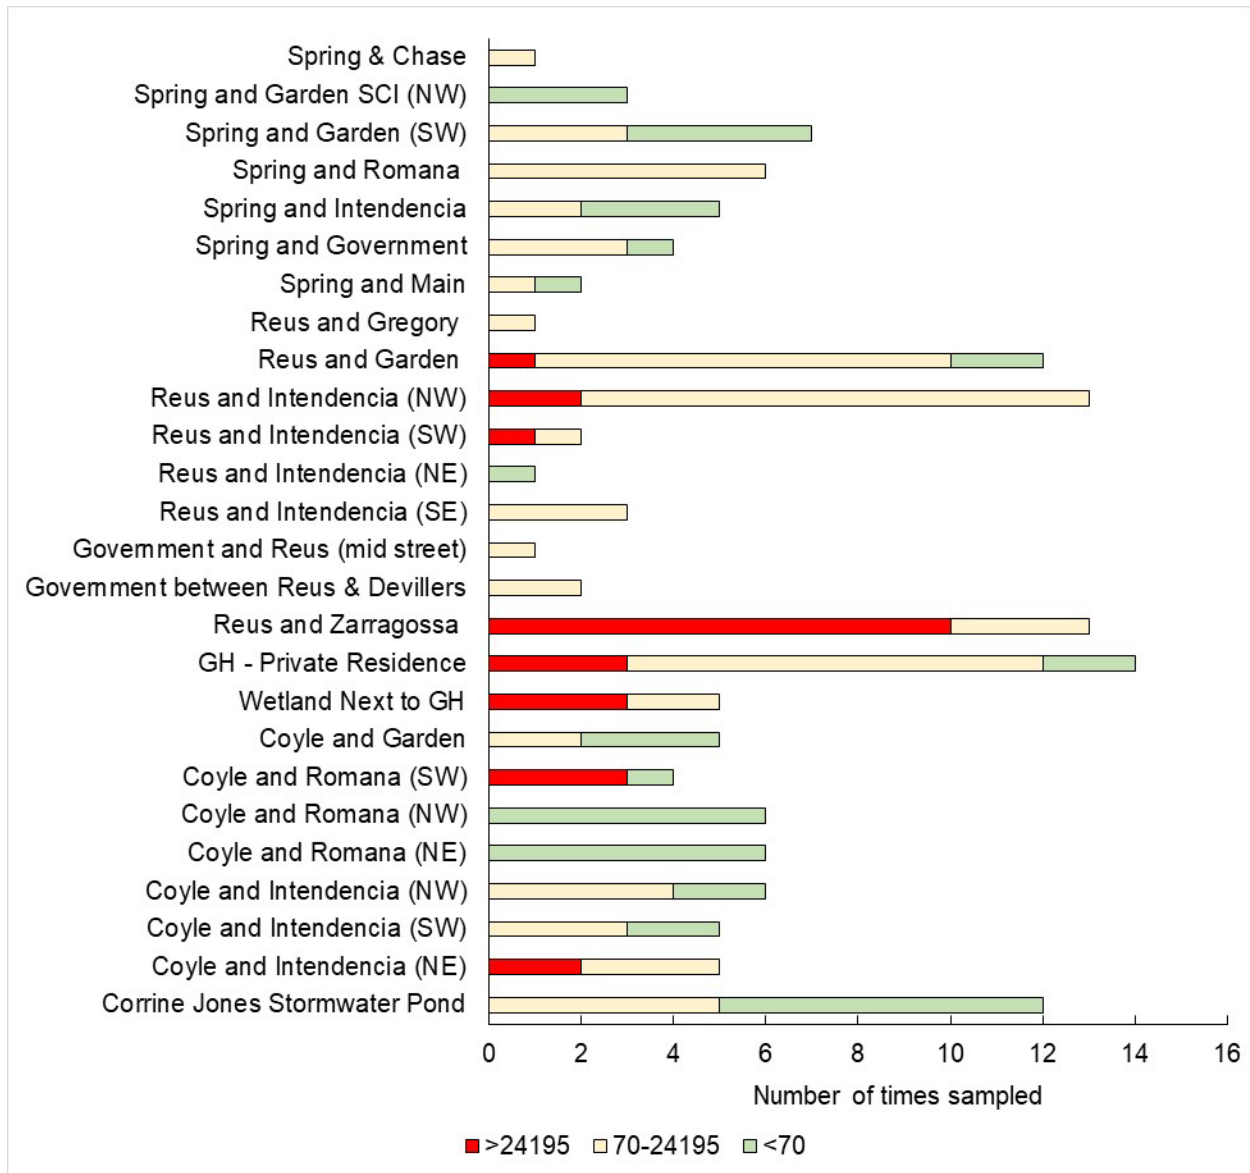
Figure 7 - Sampling locations and the number of times each site was sampled. Color bars indicate the range in value on each sampling date with red at or above quantification limits (24,195), tan indicating samples were between 70 and 24,195 MPN/100 mL and green indicating samples were 70 MPN/100 mL or less.

Five sites were sampled on almost all trips (Fig. 7). They were Reus and Garden, Reus and Intendencia (NW), Reus and Zarragossa, GH, and Corrine Jones stormwater pond. Except for the

Corrine Jones stormwater pond, all locations were always above the 70 MPN/100 mL threshold with Reus and Zarragossa above quantification 10 out of 13 sampling trips (Fig. 7). This was the site with the most consistent and highest *Enterococcus* levels. Other locations in this low-lying area such as GH, and wetland next to GH were also usually above the 70 MPN/100 threshold.

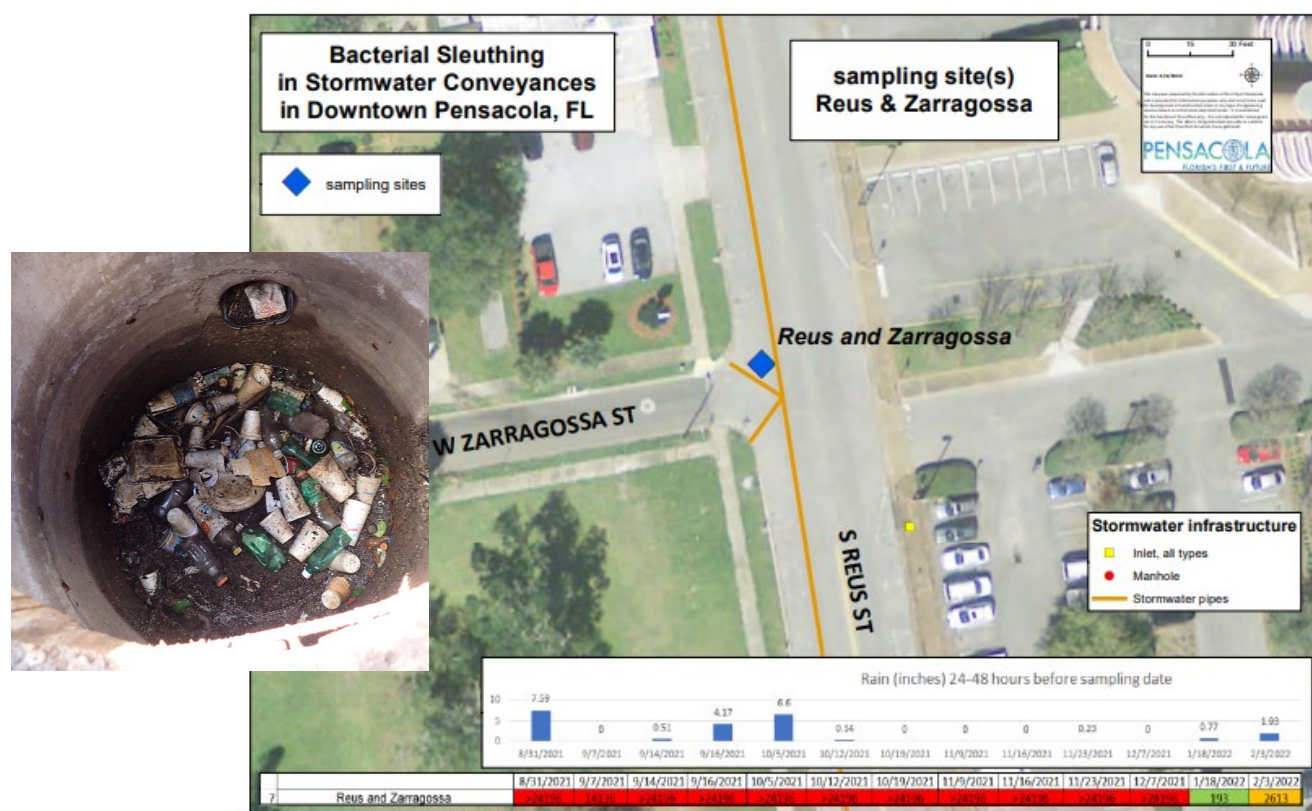
Figure 8 - Reus and Zarragossa intersection showing sampling location. Photo (left) - typical view in stormwater inlet.

A single inlet was sampled at this location during each sampling event (Fig. 8). *Enterococcus* levels were consistently too high to be enumerated (above 24,196 MPN/100 mL) in all samples collected between August and December. The photo on top left was typical for this site showing stormwater with lots of trash (Fig. 8). There was no trash on January 18th; it appeared to have been cleaned out. This was also the date with the lowest value, although at 193 MPN/100 mL, it was still above the threshold. On February 2nd, the last day it was sampled it was 2,613 MPN/100 mL.

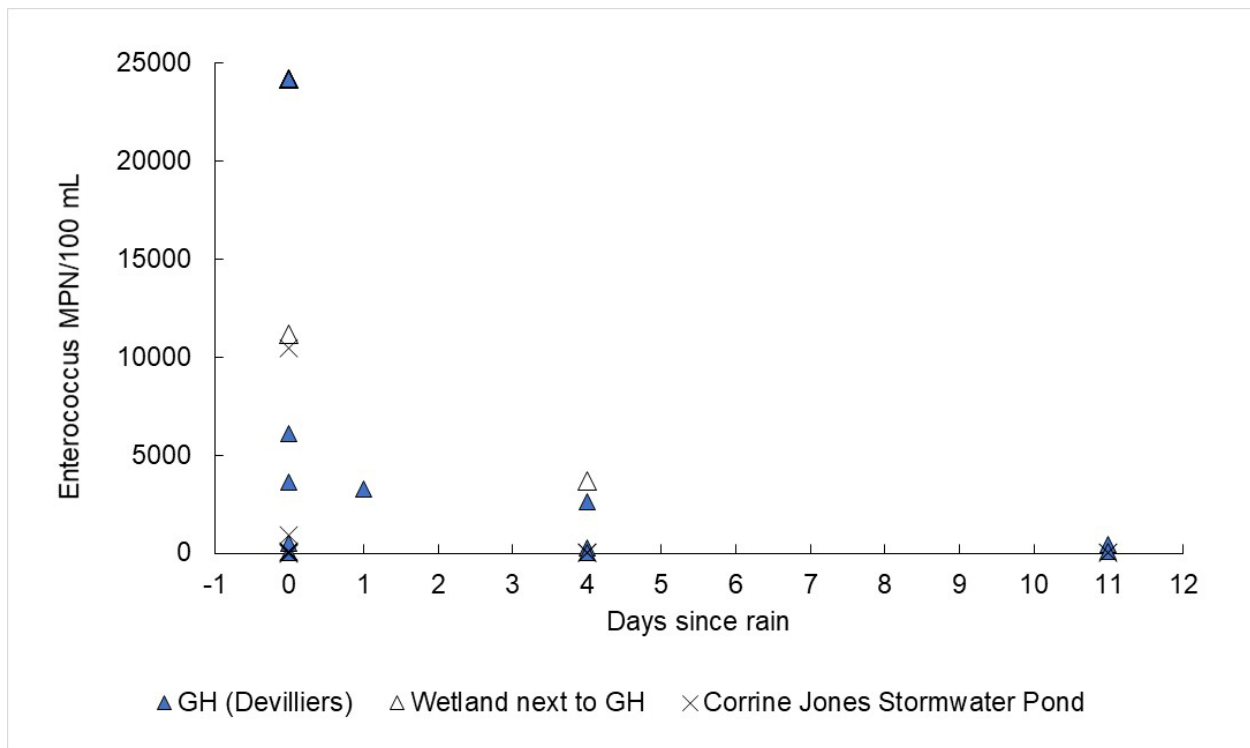
Figure 11 - *Enterococcus* (MPN/100 mL) at sites GH on DeVilliers, Wetland next to GH and Corrine Jones stormwater pond versus days since rain.

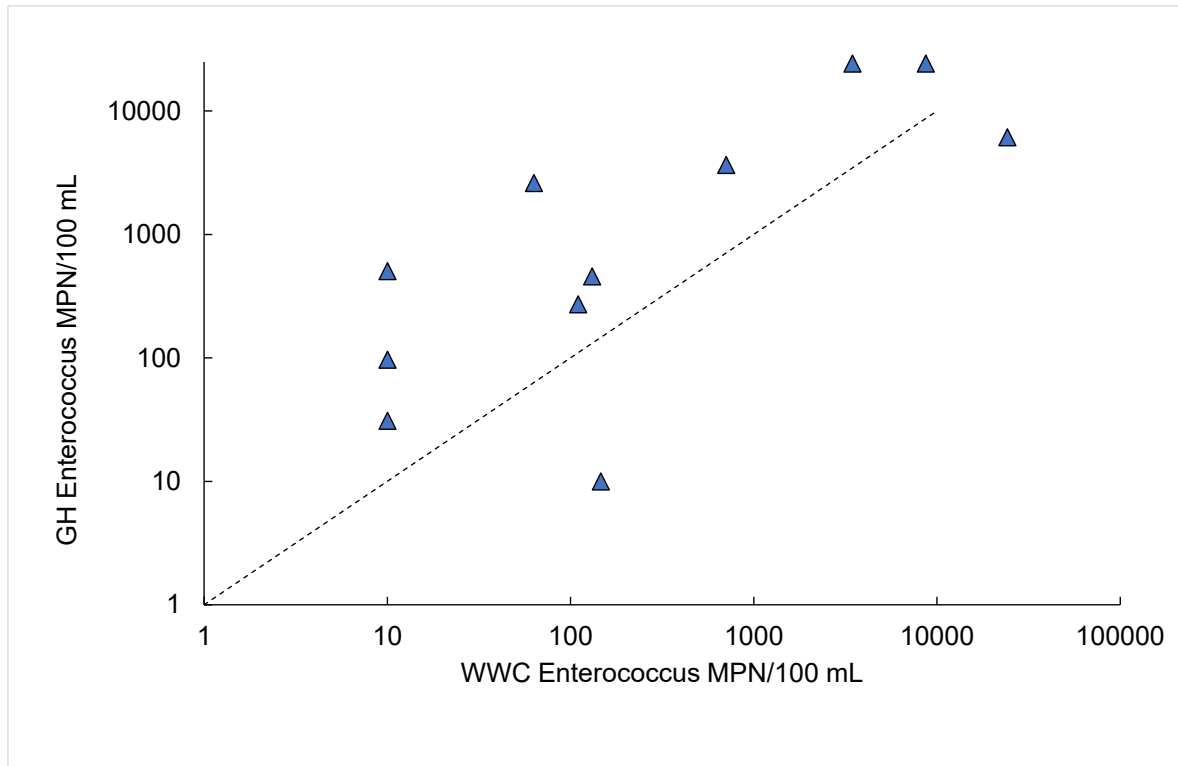
Figure 12 - *Enterococcus* at Washerwoman Creek (WWC - x axis) versus at GH site (y axis). Dotted line is 1:1 line.

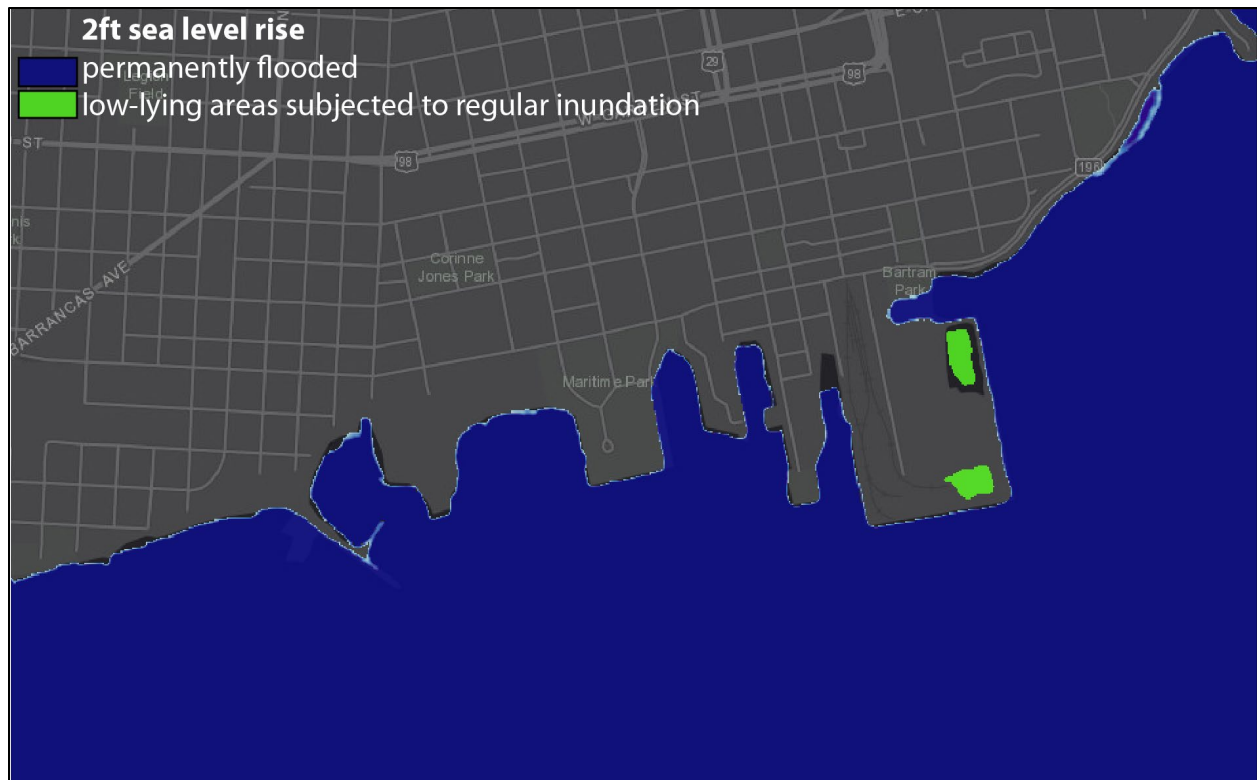
Figure 1. NOAA Assessment of sea-level rise hazards to downtown Pensacola and the Tanyard neighborhood, subjected to 2 ft (likely by 2100AD) sea level rise. Retrieved from: <https://coast.noaa.gov/slr>

Residents report flooding is caused by intense rainfall. An assessment by NOAA indicates that sea-level rise is unlikely to independently cause flooding in downtown Pensacola (Fig. 1). Similarly, Tanyard flooding during tropical cyclones are more likely caused by extreme rainfall than storm surge, based on predictions from NOAA (Fig. 2).

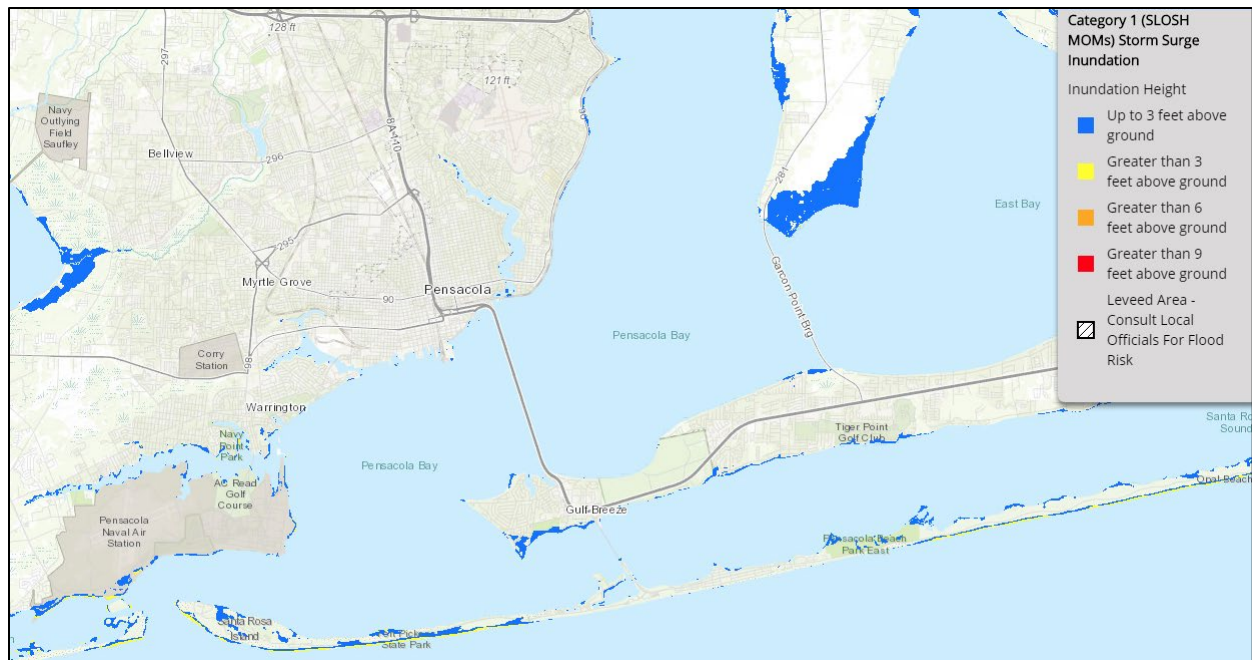
Figure 2. Maximum storm surge inundation in Pensacola estimated for cat. 1 hurricane winds.

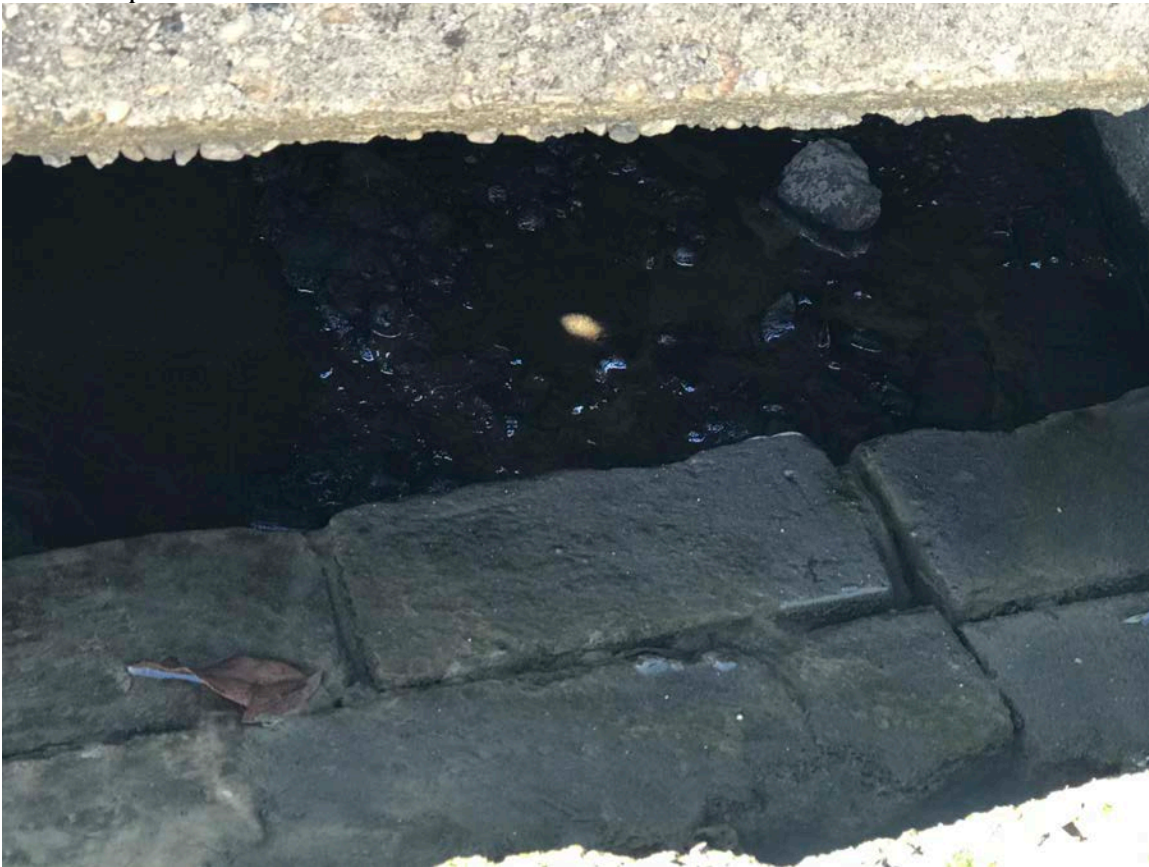
During dry periods, tidal influence continues to fill stormwater inlets, reducing the capacity to drain water. On top of this, ECUA has been Dewatering to the inlets adding even more water to a system that cannot handle basic rain events. The Dewatering has also created illicit discharges, such as sand and gravel from this operation to the inlets due to poor perimeter controls on nearby construction sites. Here is a picture below:

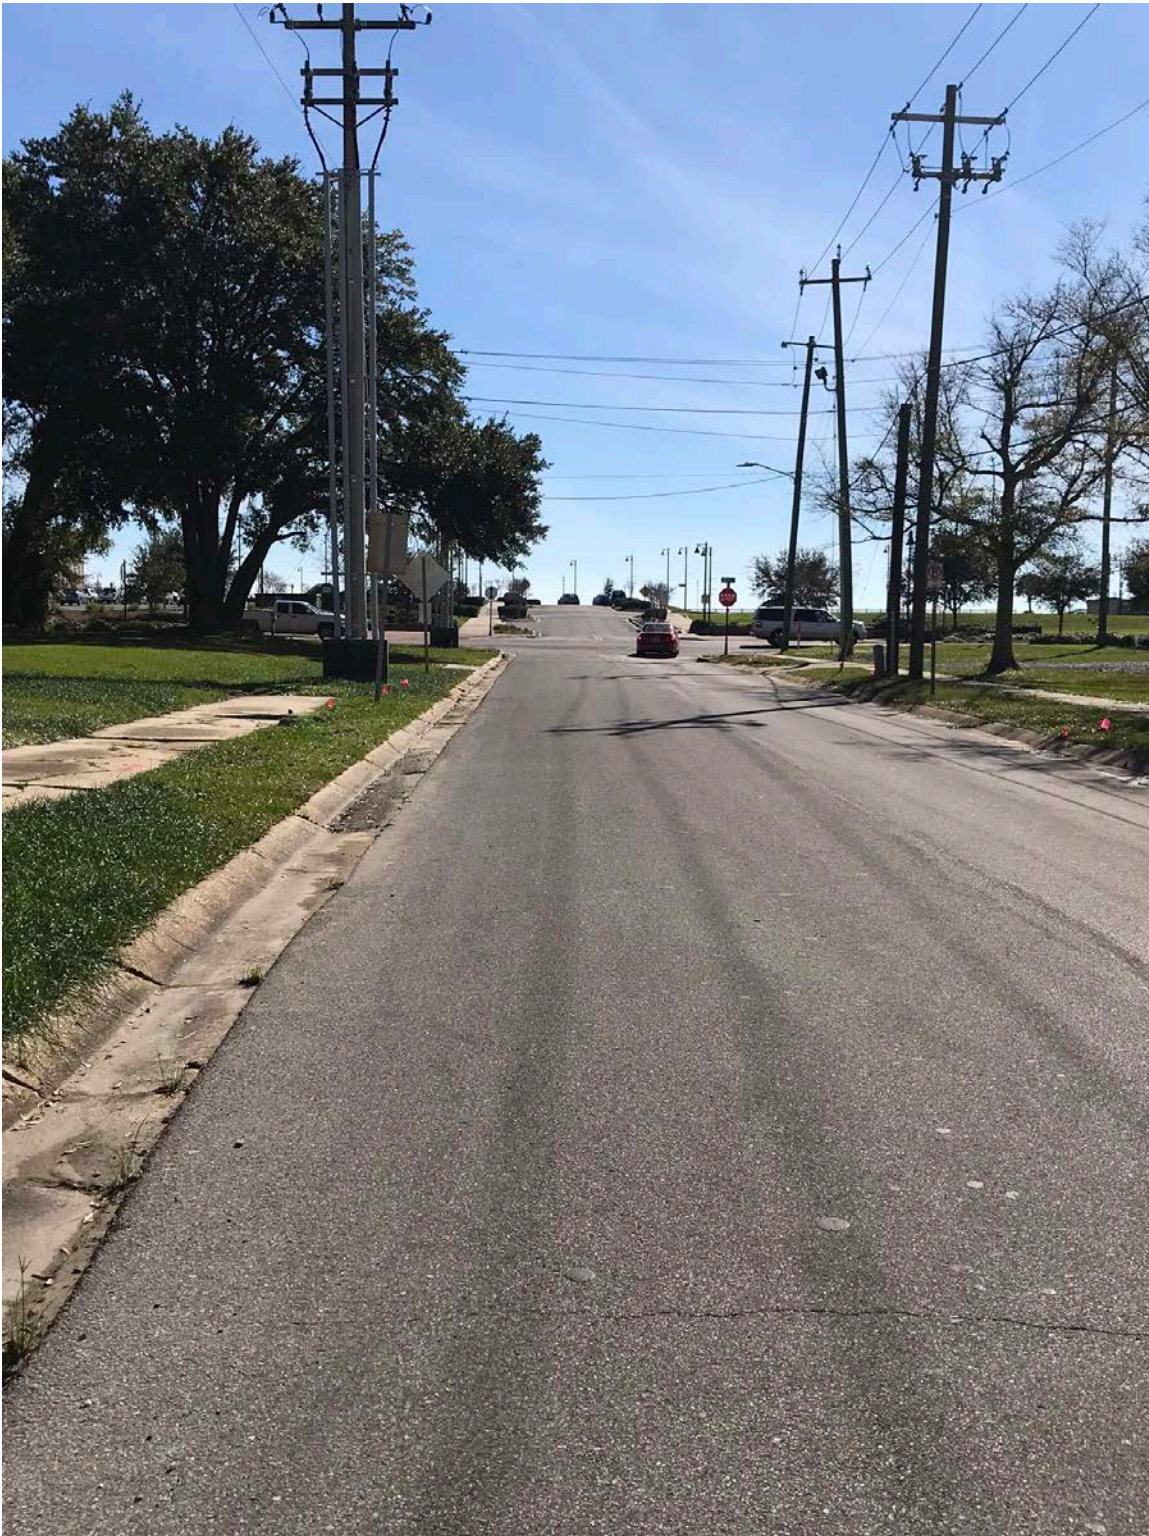
Dr. Horning's property lies in a depression due to a grade differential in each direction from her property. The amount of sheet flow increased from the property south of Main when it was raised to the FEMA BFE, increased by Three (3) feet and allowed to utilize fill for structural support to raise BFE without having to raise the structure itself to be placed on pilings for example. This created an elevation

increase of up to 14-15 feet. However, it does state in the Land Development Code that as long as...*"the subject fill does not cause any adverse impacts to the structure onsite or **adjacent** structures."* Here is a photo below:

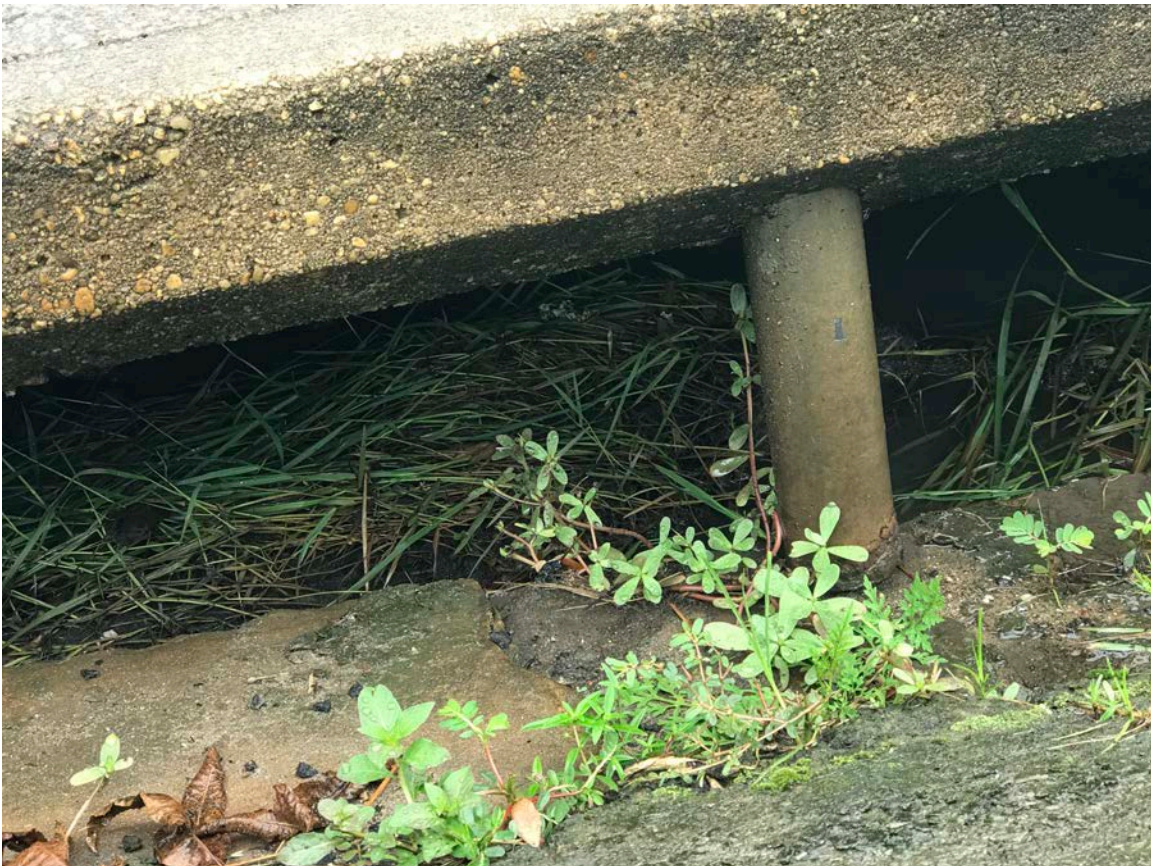
Zaragossa to Ruess and Government to Ruess contain no stormwater inlets. There are inlets located at DeVilliers and Zarragosa and the North side of Government and DeVilliers. These have been problematic for years due to tidal influence and illicit discharges. Last year, I had to contact the City Public Works Department to have them vacuumed out. Half of a pickup truck bed was filled with an assortment of items that *mainly* consisted of contractor items. Several trees 12-18" and other assorted vegetation was also recovered growing inside the inlet due to an abundance of sedimentaion.

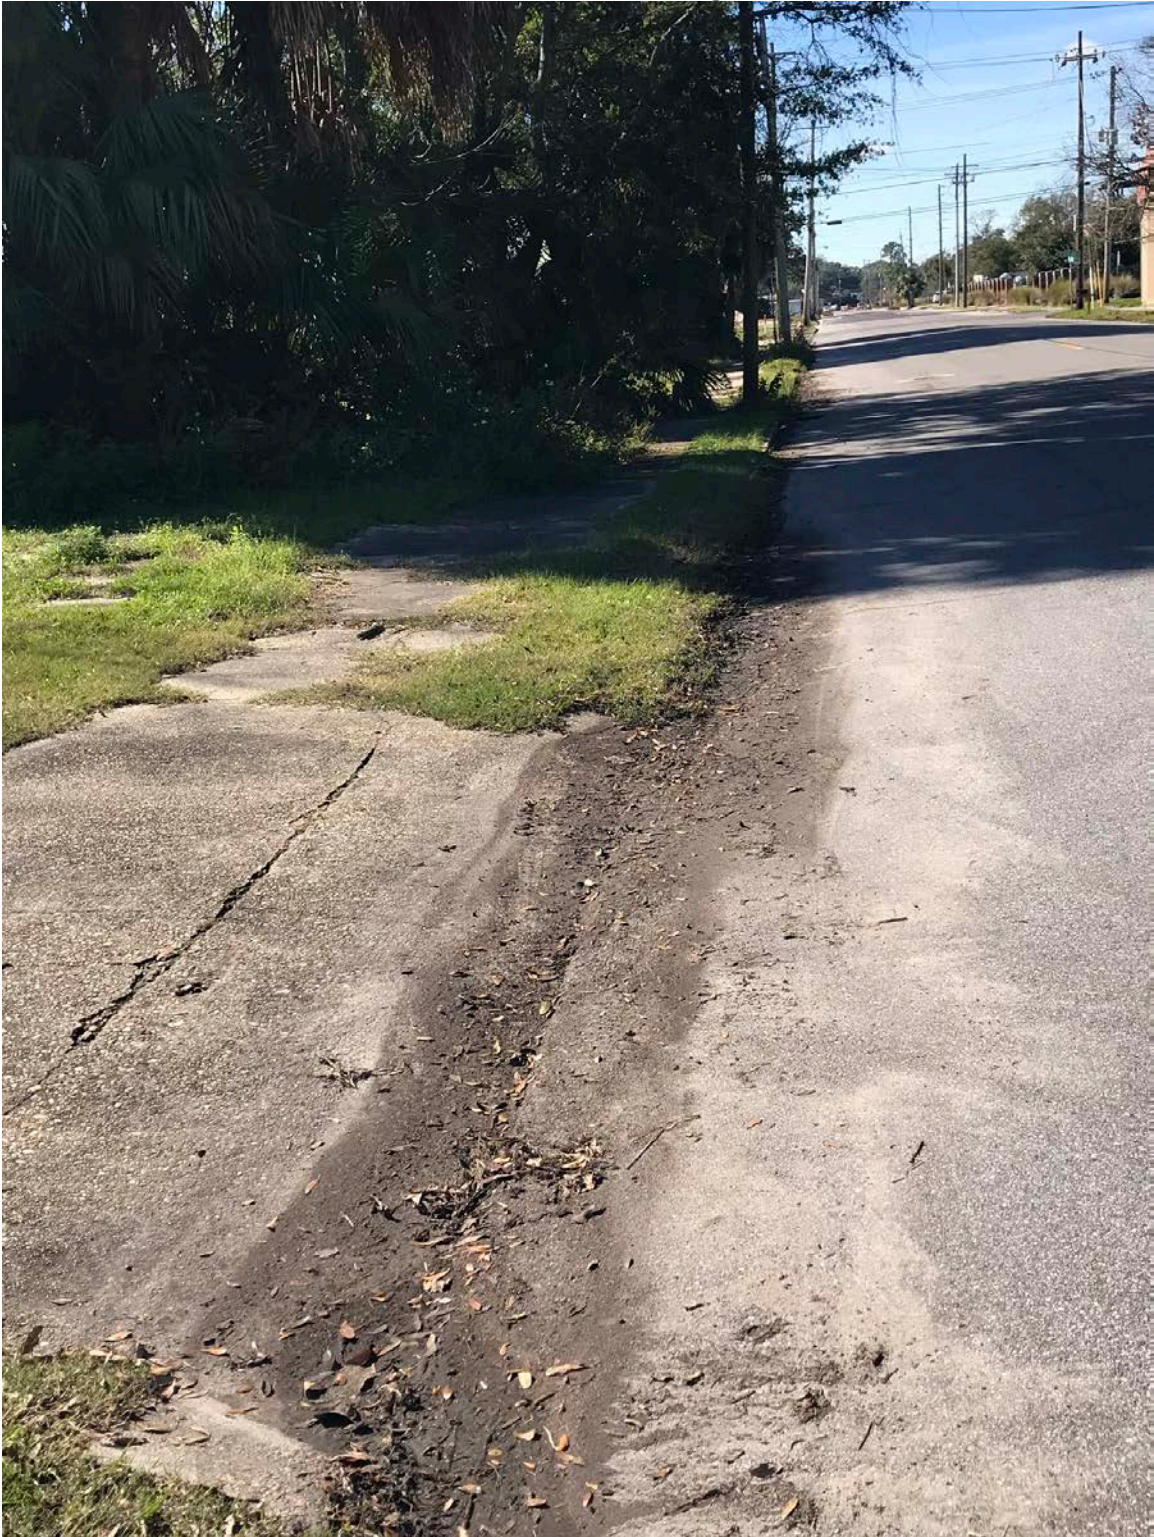
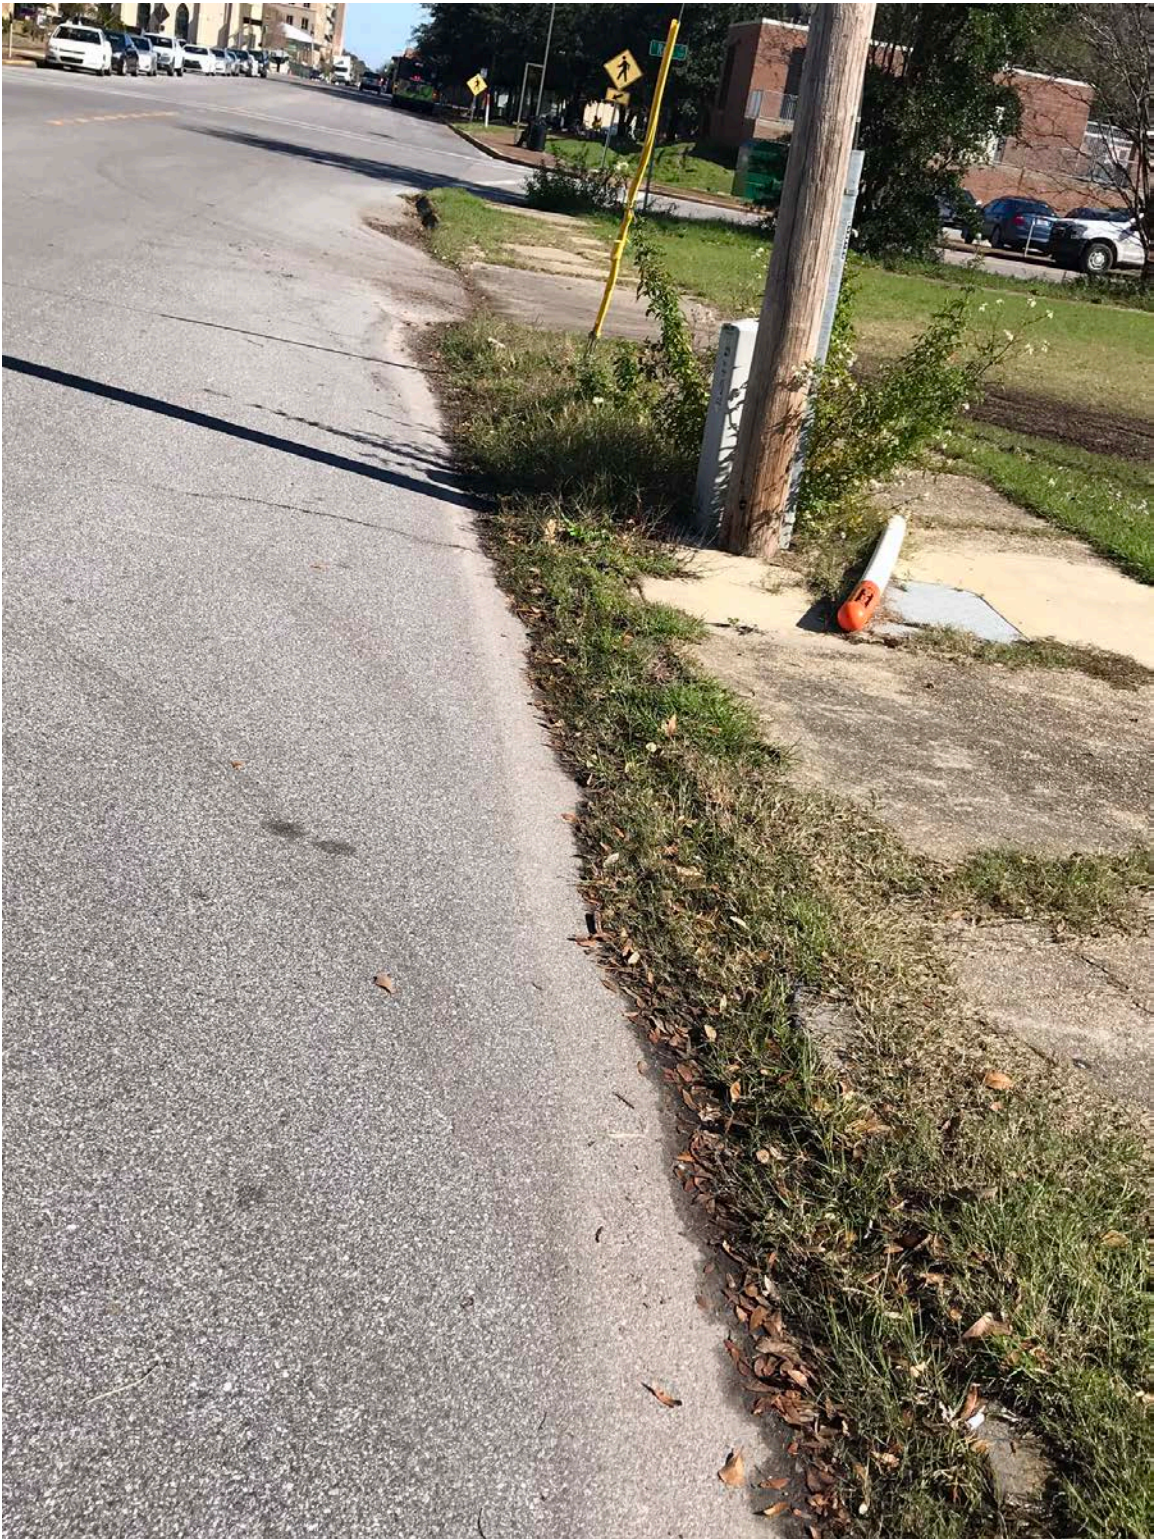
Many of the surrounding streets contain no curbs or ways to divert or infiltrate stormwater. Property owners there suffer due to receiving everyone else's stormwater drainage. I interviewed two additional residents there that reside close to Dr. Horning. One resident, Joe Behrend, at 320 W. Zarragossa (behind Dr. Horning's property) stated to me Monday that he has not been able to use his

detached garage for months due to drainage issues. He's afraid that his vehicle will get stuck on the dirt driveway that leads to his garage. Here are some photos of curbless streets on Government Street and W. Zarragossa, East of DeVilliers:

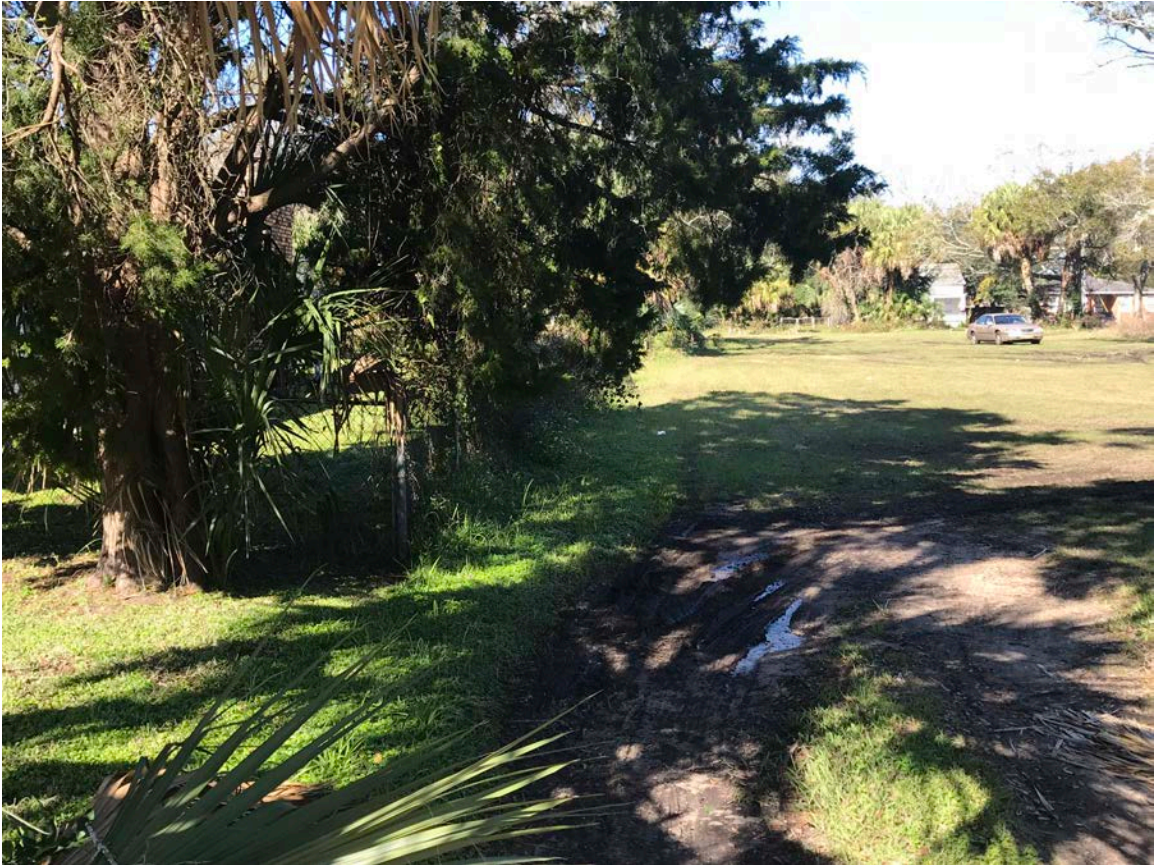
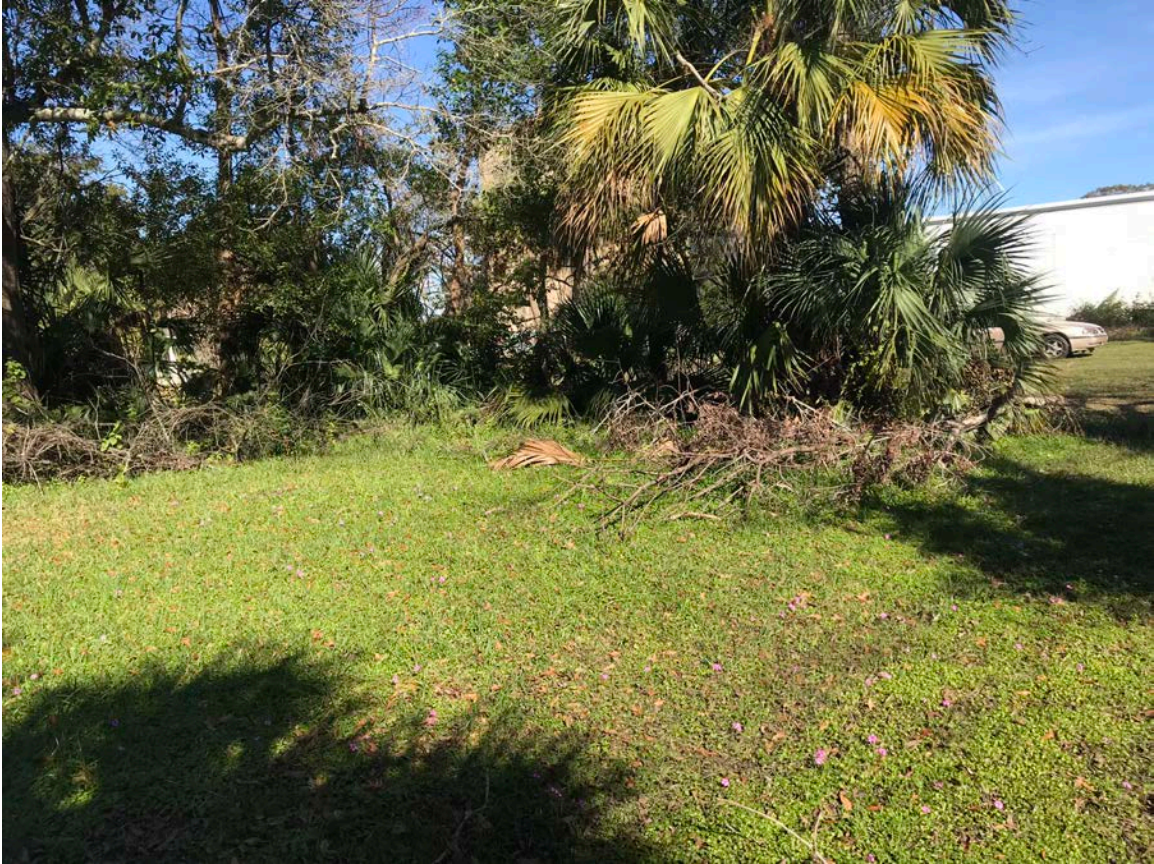
There are several small tracts of land mainly owned by W Government LLC that fall west of the Union House Restaurant owned by Trustee of Sarah Groeger. These lots

are currently vacant, but are used to dump landscape vegetation, compacting the soil even more so, which increases velocity of sheet flow to Dr. Horning's and Mr. Behrend's property. See photos below:

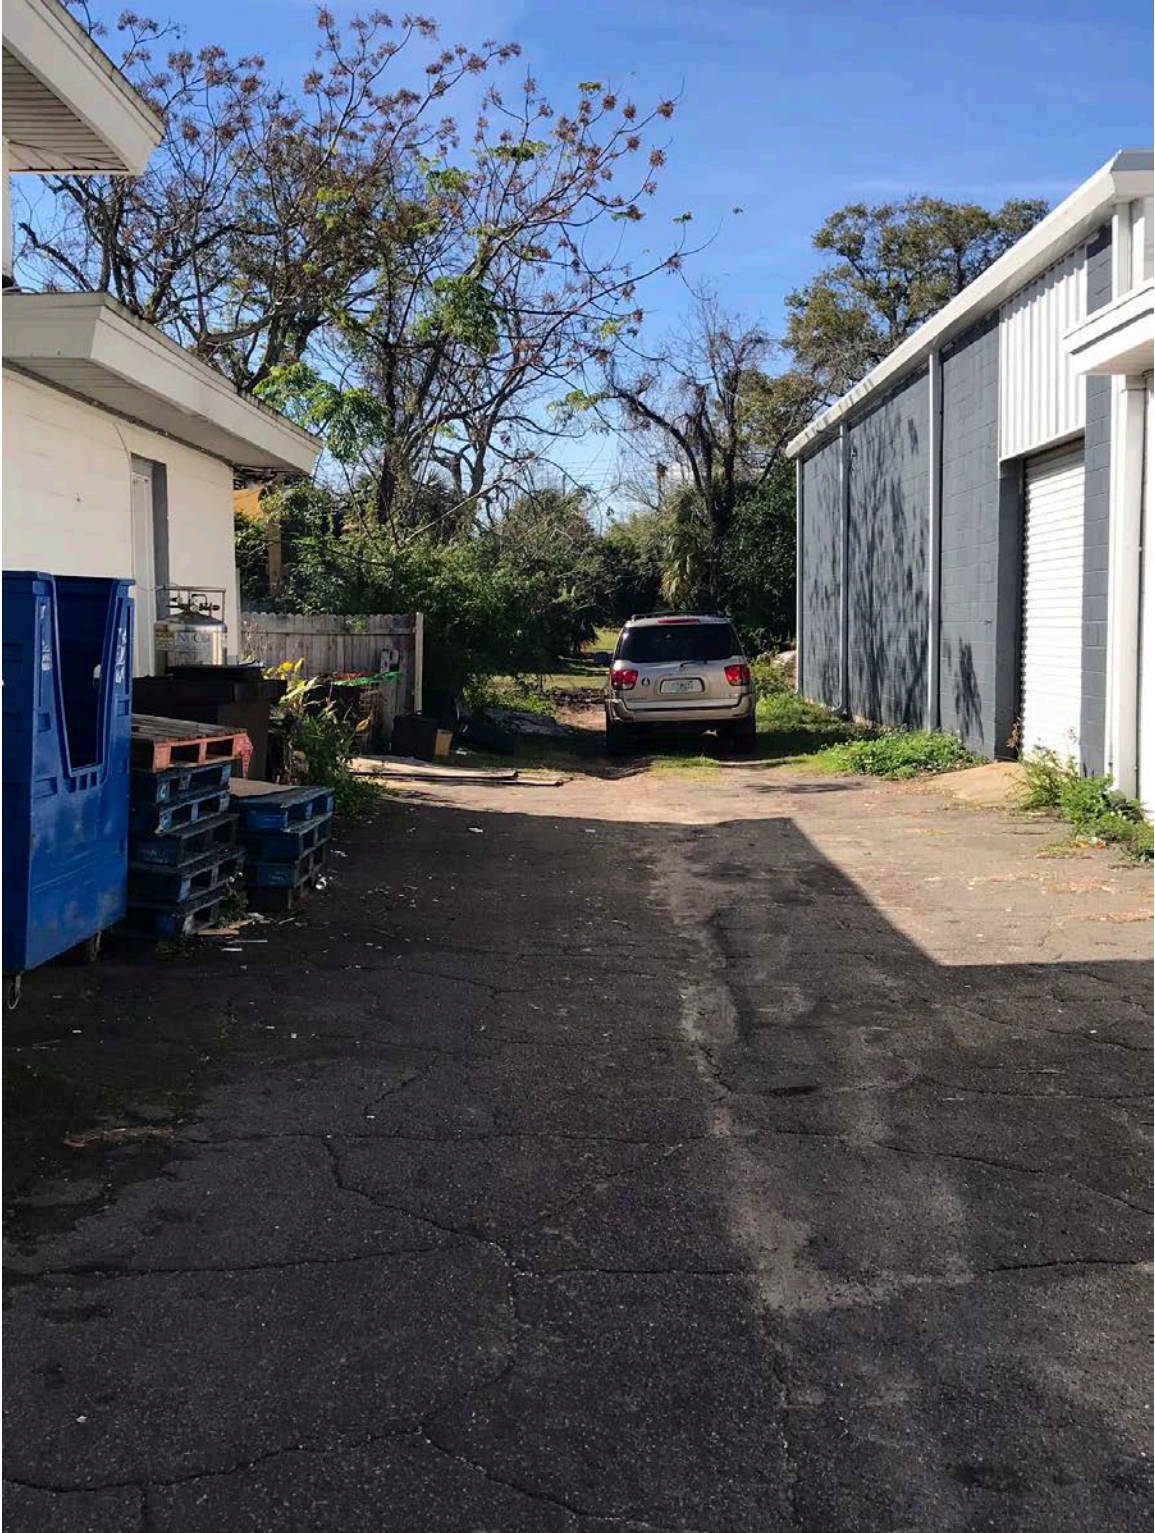
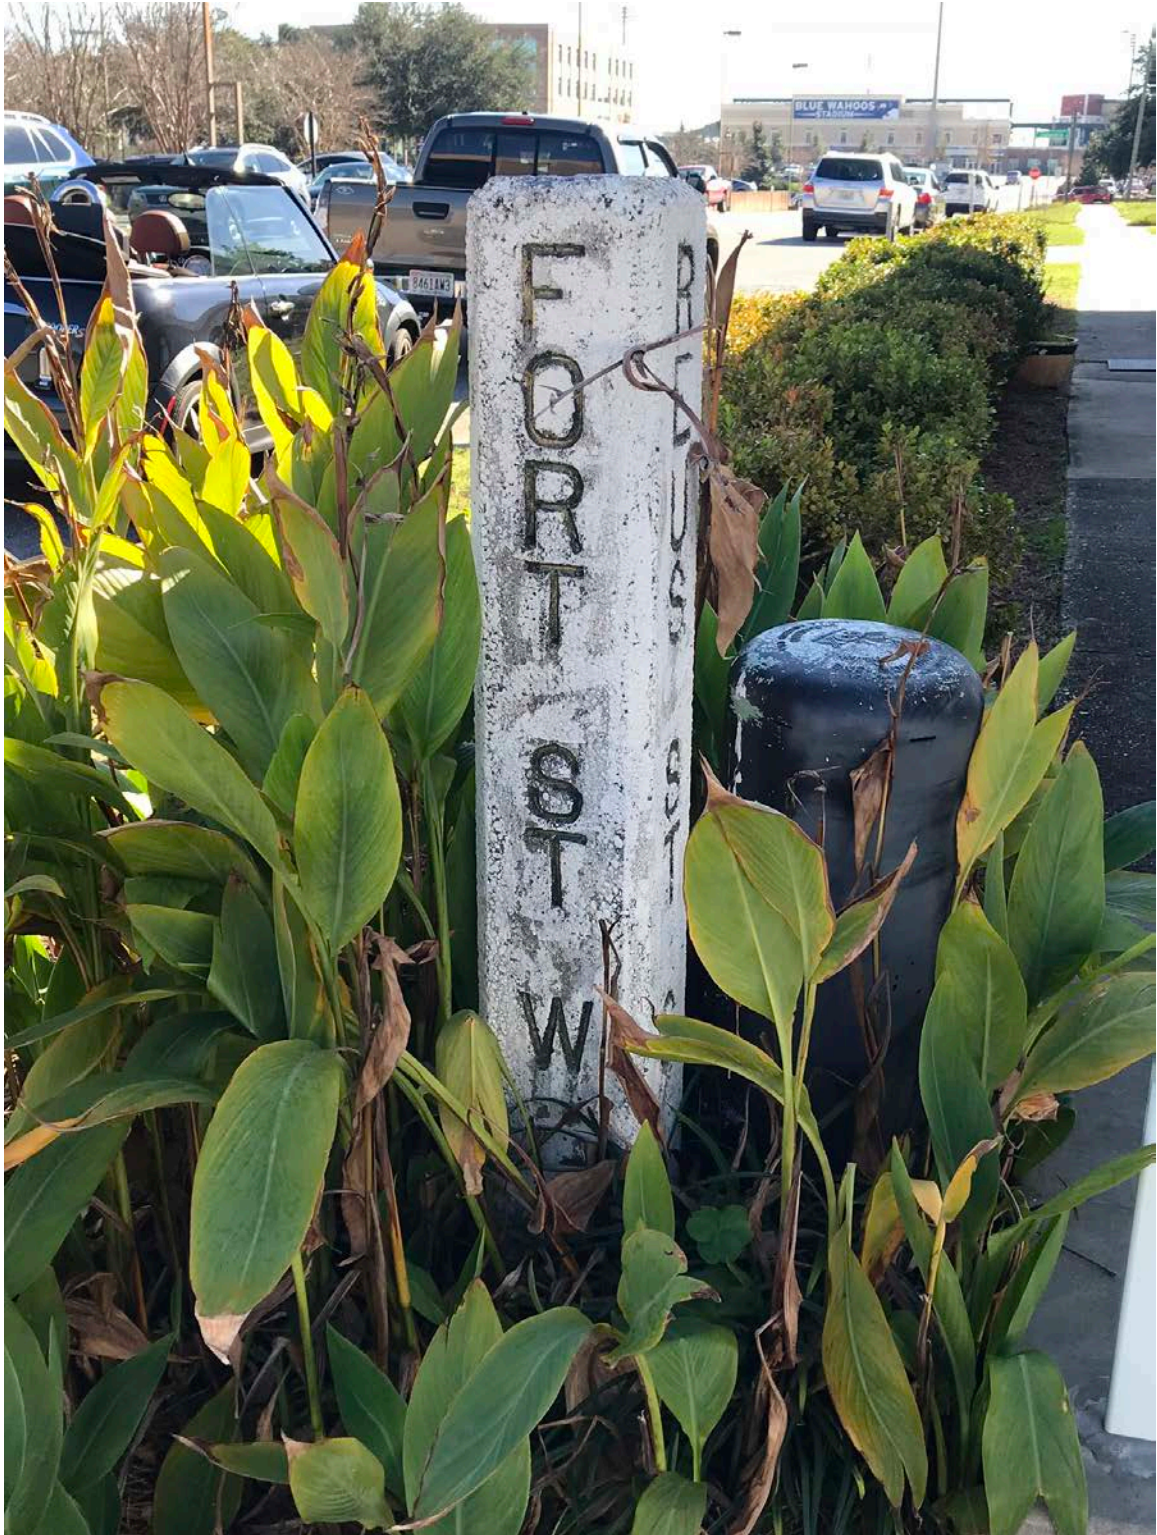
Fort Street W

The Union House Restaurant creates a large amount of stormwater to properties west of it, including Dr. Horning's and Mr. Behrend's. For example, flat roofing with only a couple of downspouts generate an increase of volume and velocity of stormwater. Because the grade slopes west and the lots are compacted between the residents and this restaurant (not including low water tables *and* there is not enough stormwater infrastructure for the design and lot of this property), it is my opinion that this is part of the problem, which is an easy fix. Stormwater should be maintained and infiltrated just behind the restaurant, preventing the westward sheetflow movement through onsite attenuation or infiltration. I'm attaching photos below:

The first photo shows the driveway between the Union House Restaurant going towards Dr. Horning's and Mr. Behrend's property. This used to be W. Fort Rd and ran all the way through Clubbs Street.

The second photo shows the side of the building, also showing compaction of land, allowing increased volume and velocity of stormwater onto residents' property.
