Identifying Stormwater Sources of Microbial Contamination at Bruce Beach, Pensacola, FL

Technical Report to City of Pensacola

July 29, 2022

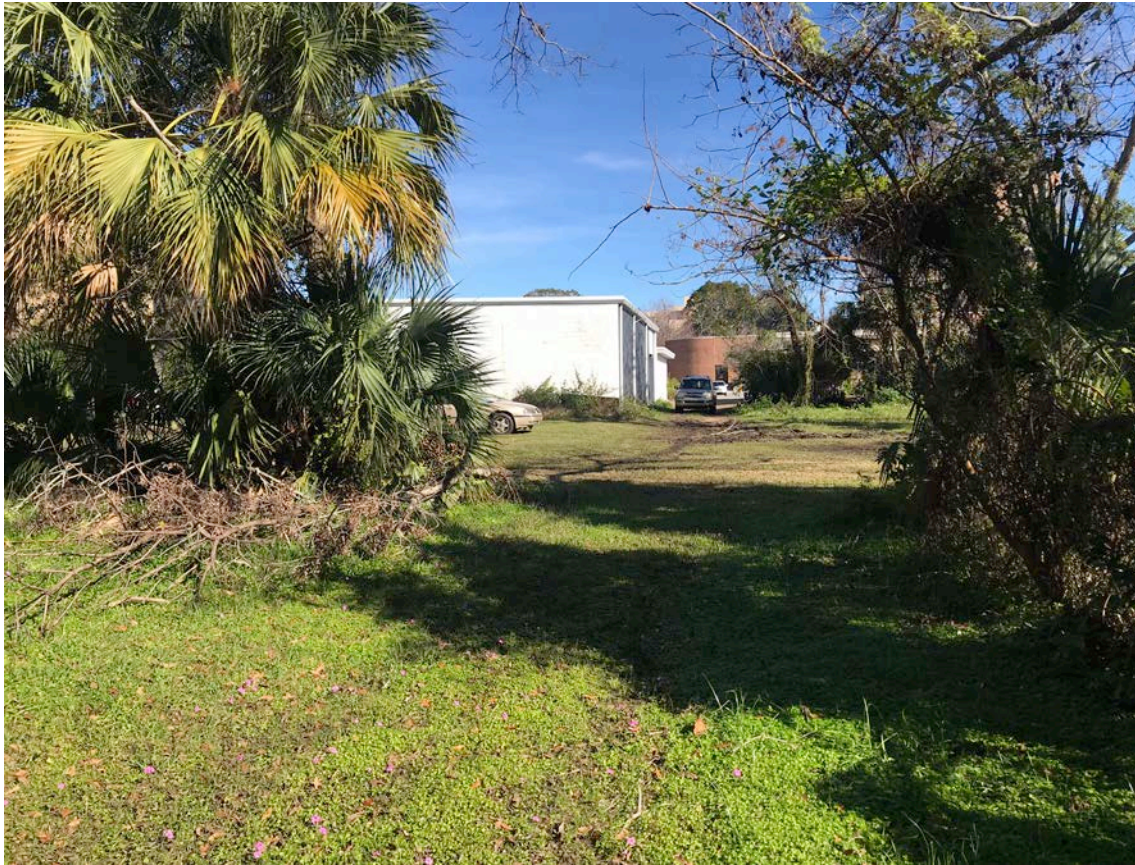
Looking towards the Union House Restaurant from behind Mr. Behrend and Dr. Horning's residences. This is the avenue in which the water travels from the Union House westward.

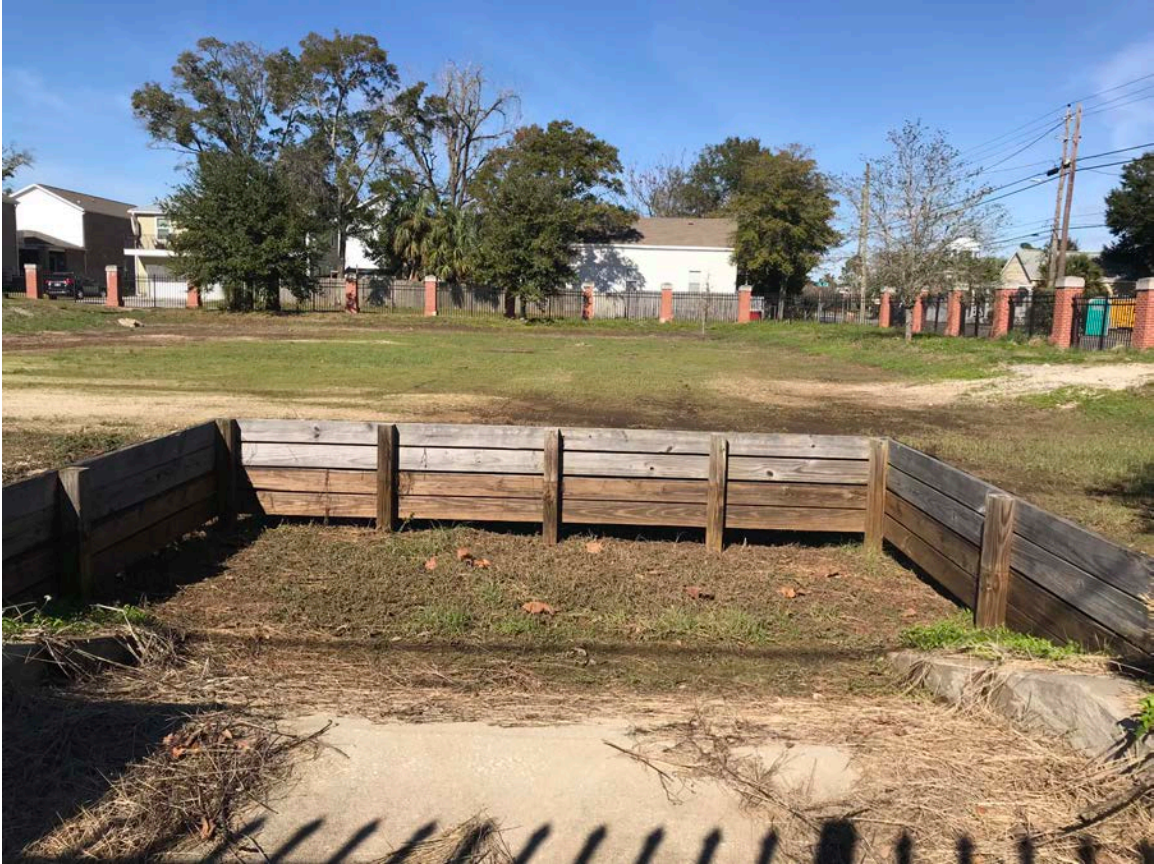
The ECUA lift station has a dry detention pond on site at Government Street and DeVilliers. This pond is very shallow and tends to overflow during heavy rain or dewatering events to Government Street near DeVilliers from a cement "driveway" installed along the fence line, allowing stormwater to pass through. There is only one small grated inlet across the street from this pond, which is not capable of taking on that type of sheet flow. I would either recommend some type of weir device to divert overflow, evaluate the dry pond to see if there are impediments to stormwater infiltration or see if the pond is the right depth considering the change in frequency and intensity of rain and Dewatering events. Photos attached below:

ECUA Dry Detention Pond at the lift station on Government Street and DeVillers

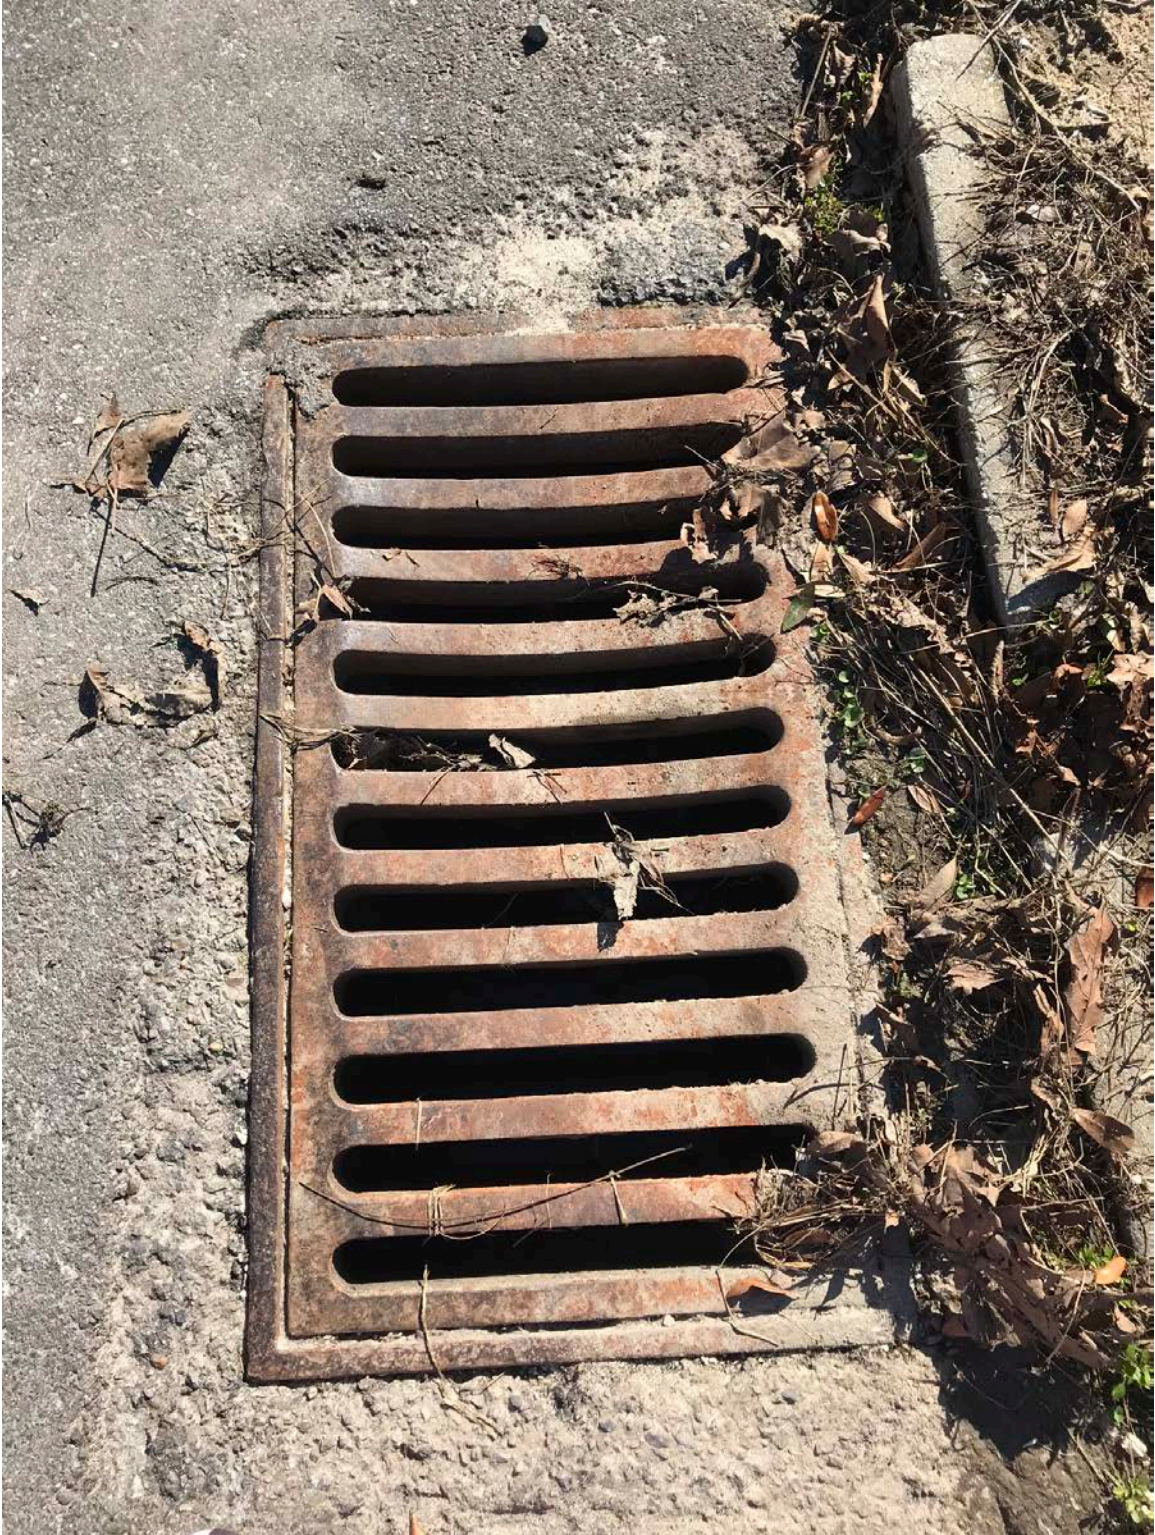
Small Stormwater Grate Inlet on the corner of Government and DeVillers Streets.

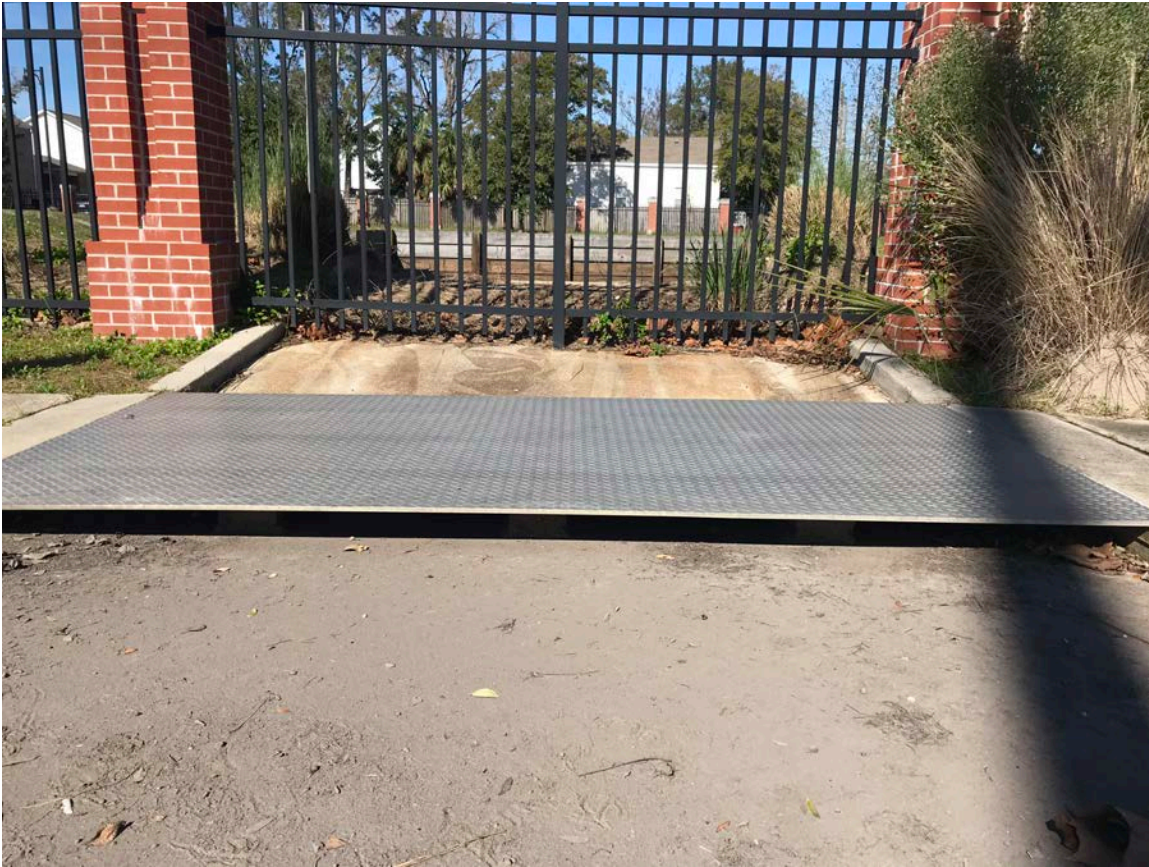
The “Driveway” that encourages overflow to Government and DeViller’s Streets

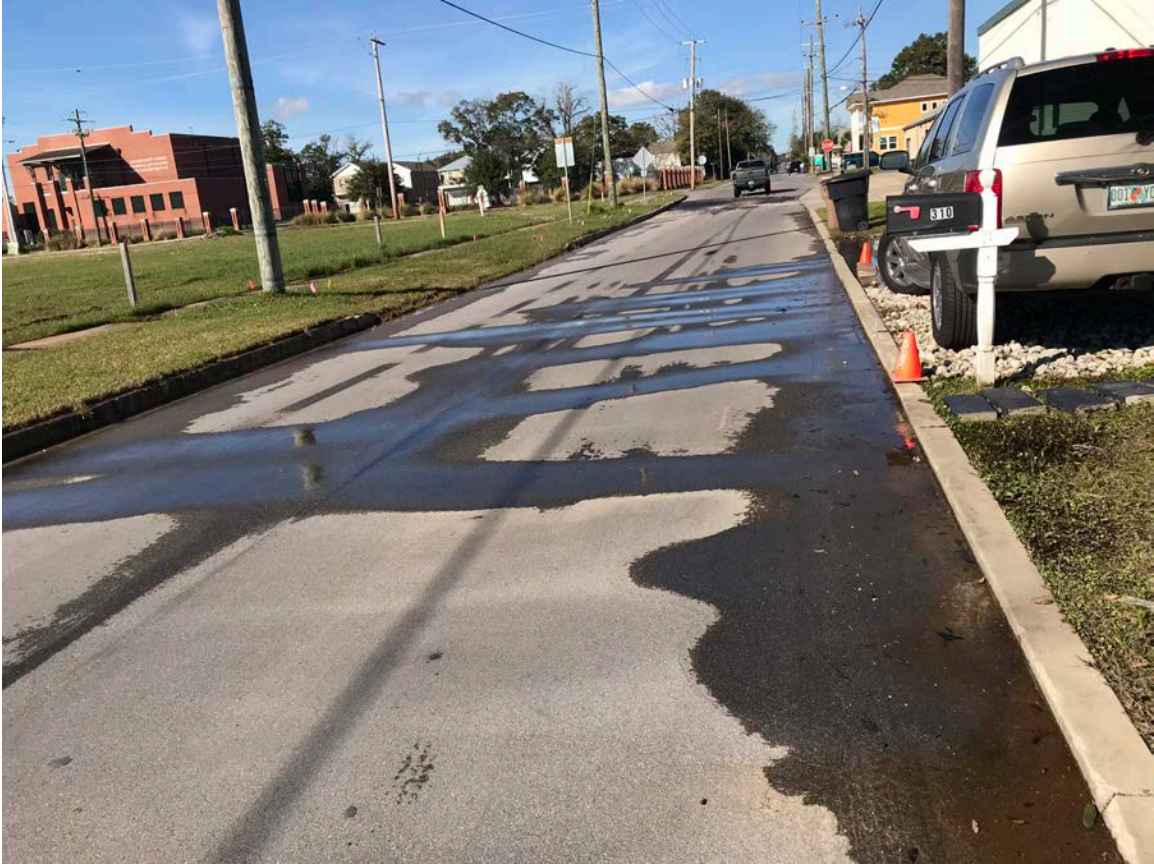
When I saw her Monday, She was trying to get her exercise in while pushing her walker. She was trying to cross DeVilliers, which was still wet and receiving run off from neighboring properties (dry day). Photos of the street below

Dry weather days in front of Dr. Horning's property

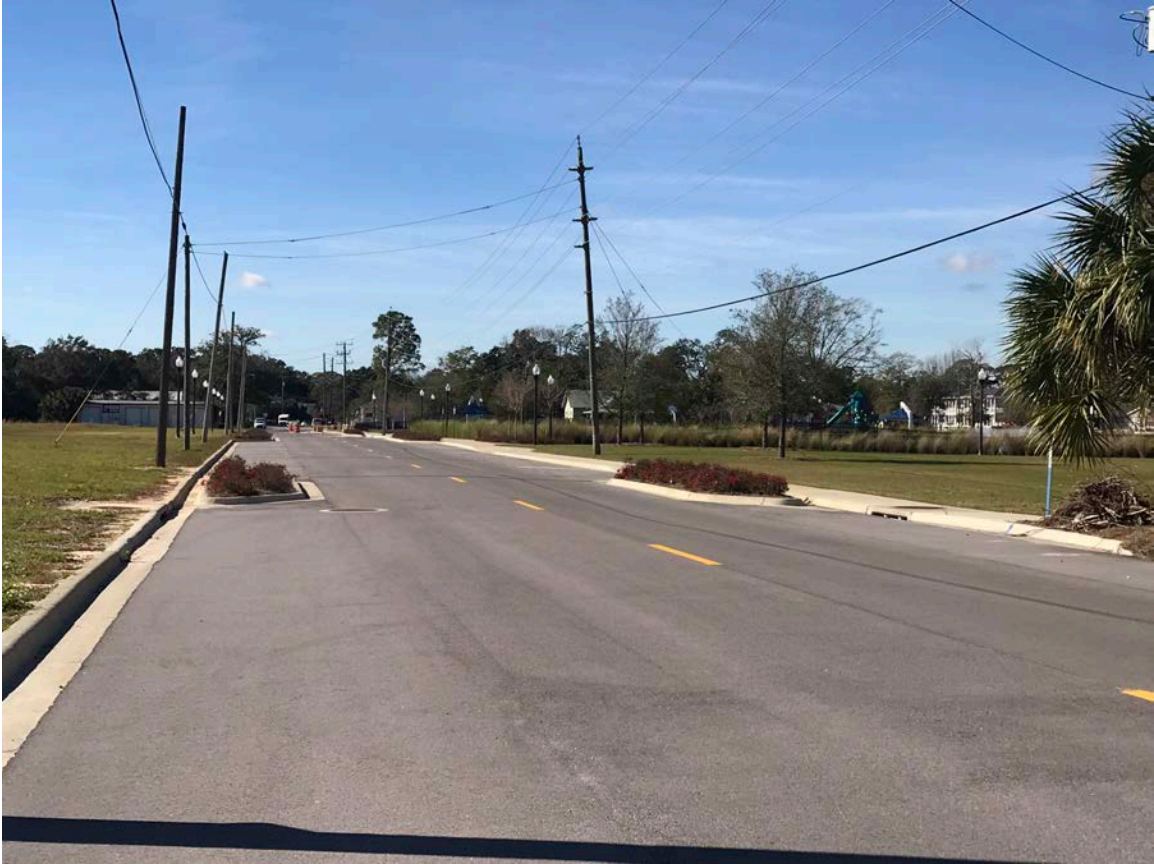
Just a block west, nice and numerous stormwater inlets. Dry Streets!
Located near Corinne Jones Stormwater Park, Government Street

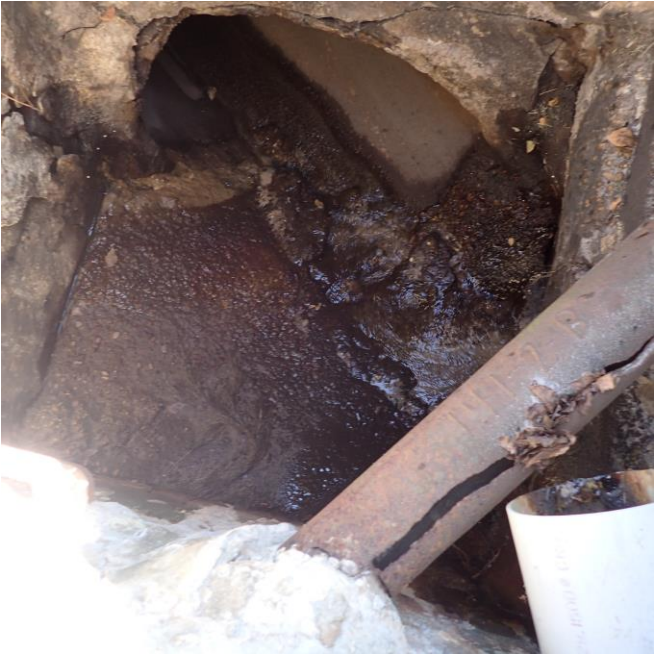
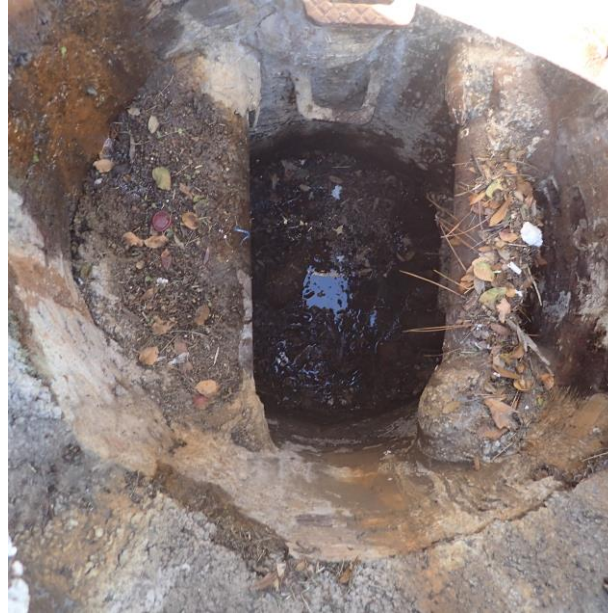
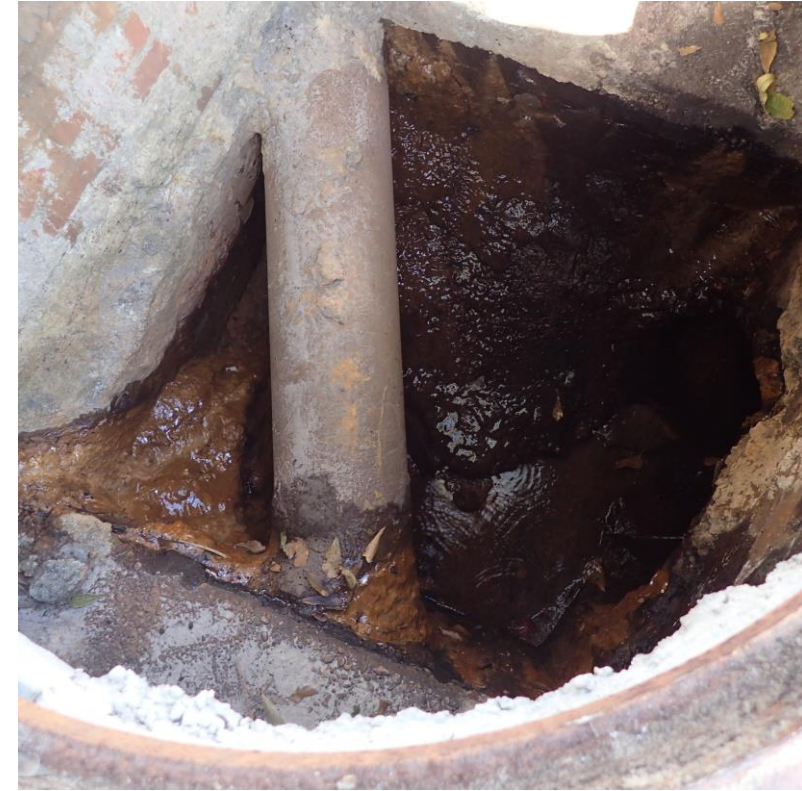
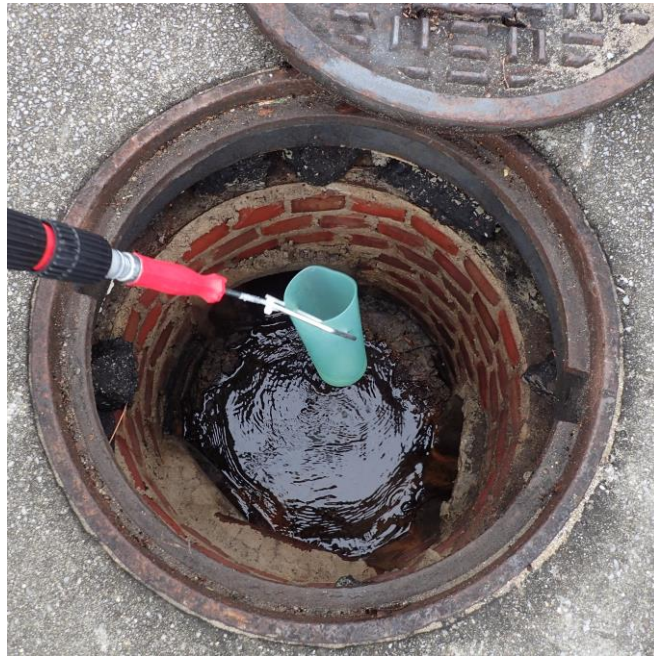
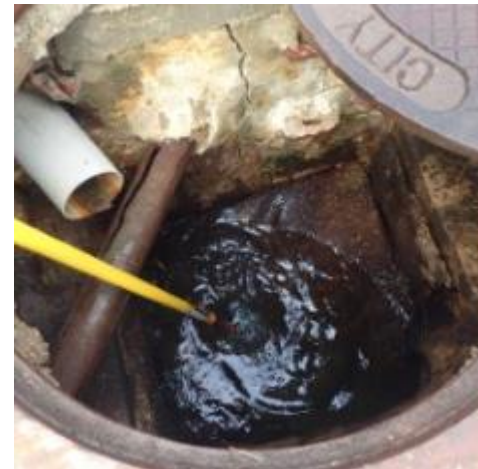
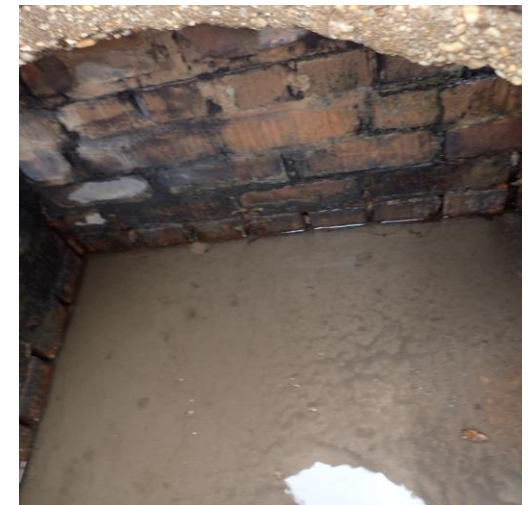
Aged Infrastructure

upwards of 10-feet deep) which serve to consolidate stormwater from other nearby inlets (Figure 4). The older, aged stormwater inlets were often observed to have seepages or infiltration of groundwater through cracks in the conveyance structure or most often, where the grout between bricks have worn away and offered easy access for groundwater infiltration (Figure 5).

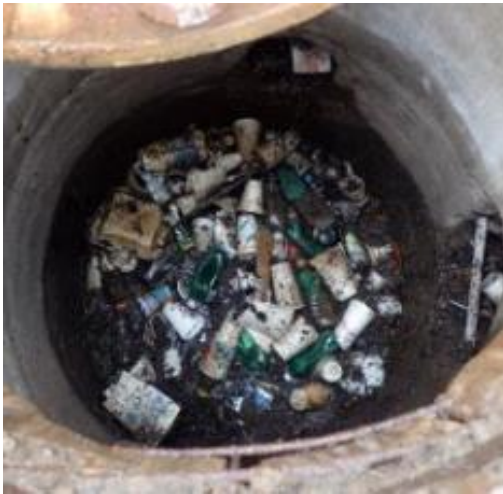
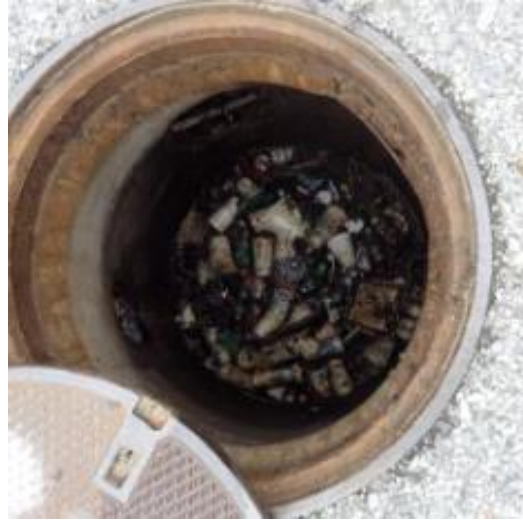
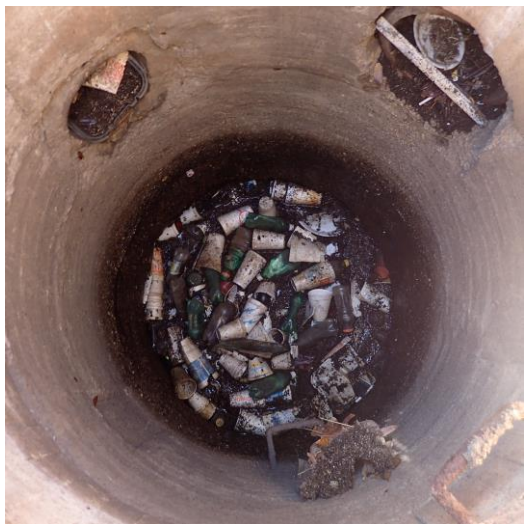
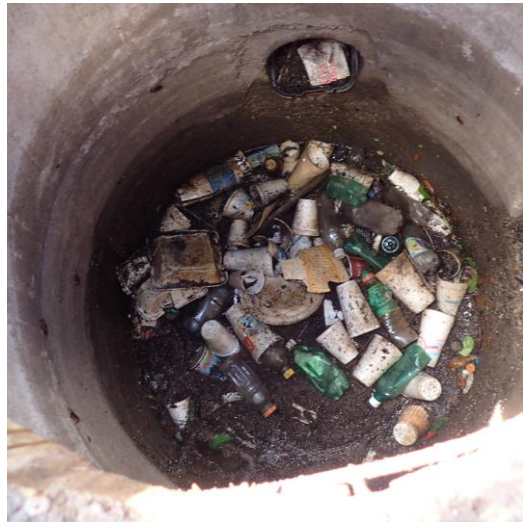
Reus and Zarragossa

Four separate inlets were sampled at this intersection (Fig 9). Are these 4 stormwater pipes connected? This was not evident during this study. On some occasions flowing water was observed and sampled in some inlets, while no water was flowing in the inlets on the other side of the intersection. Reus and Intendencia (NW) was consistently high. The lowest value (181 MPN/100 mL) occurred on September 7, 2021 with most values above 1000 MPN/100 mL. These values were high even following extended dry periods (Fig 10).

- Locations with consistently high *Enterococcus* counts (e.g., Reus and Zarragossa) should be the highest priority for identifying the exact source of these levels. Further studies with the City of Pensacola and Emerald Coast Utility Authority (ECUA) engineers will be needed.
- Improve infrastructure to minimize public exposure to potential pathogens: Minimize infiltration into stormwater pipes (missing or cracked mortar), add bathrooms at Bruce Beach to prevent local sources of human waste at the park, and reconfigure stormwater outfalls into Pensacola Bay to minimize intrusion of Bay water into drains.
