Pensacola Bay Paddling Trail Bacterial Study

Technical Report to City of Pensacola

September 30, 2022

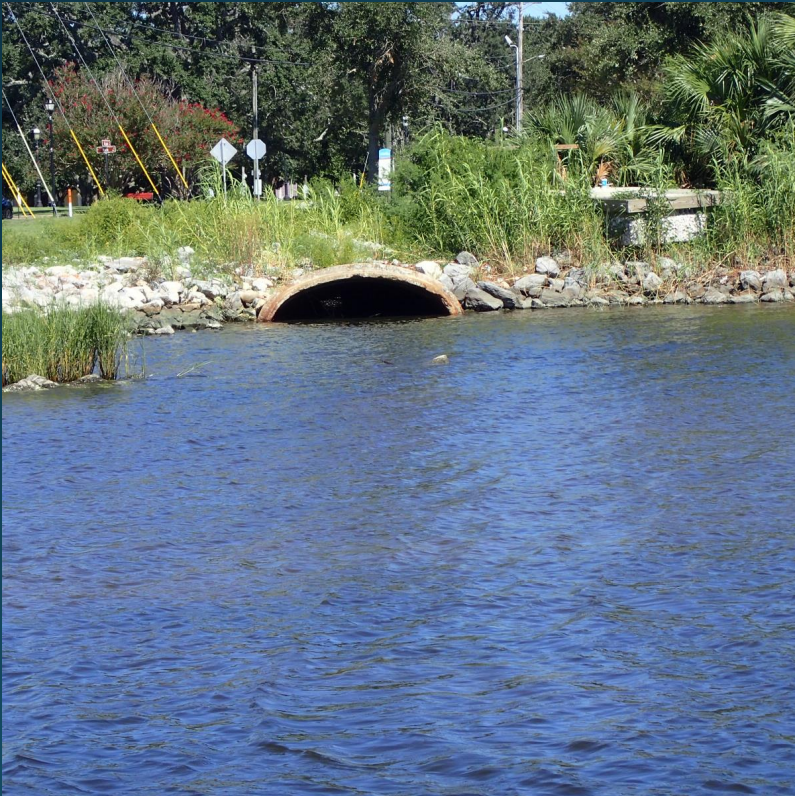
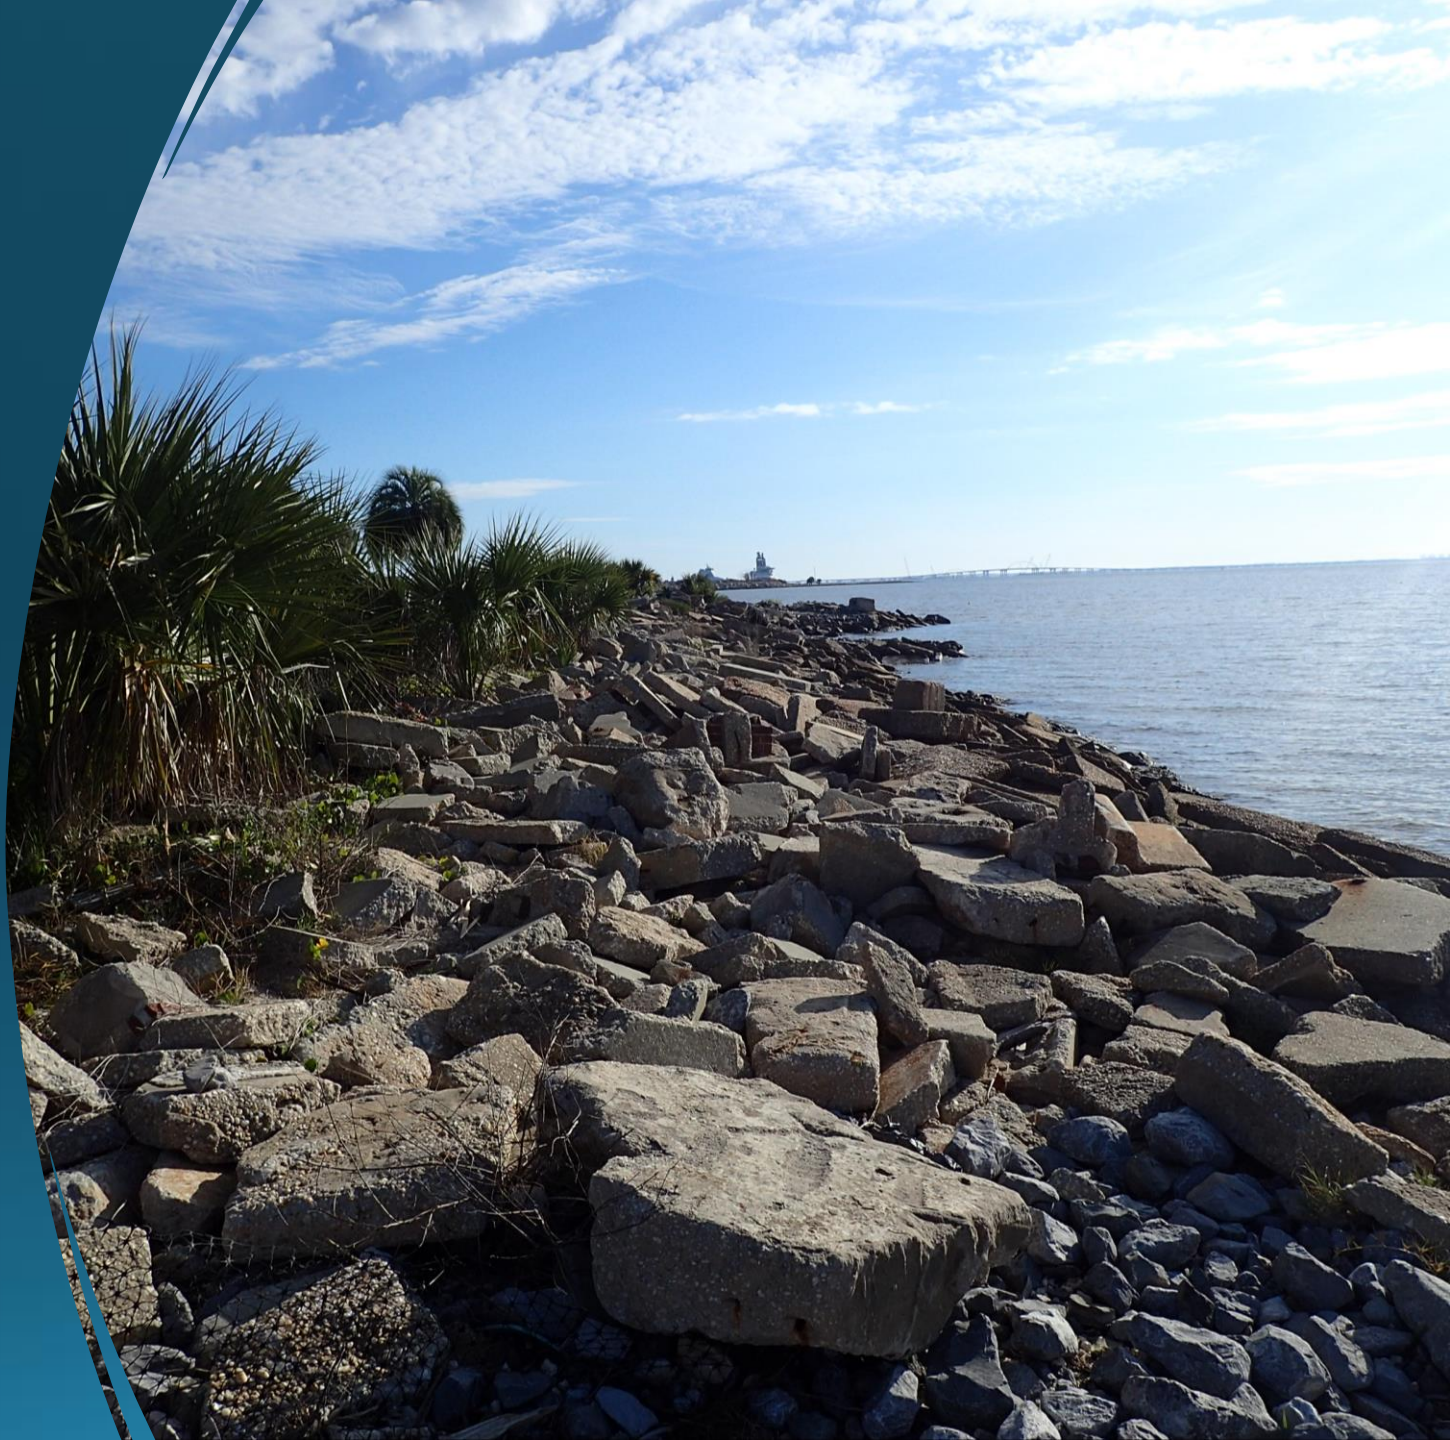
'A Street' Joe Patties No Safe Access/Egress

- A Street dead ends into a rock lined conveyance which has a tank farm to the east and a rock lined berm to the west until it enters a small embayment.
- Fishing and shrimp boats use this cove as a protected water and to unload their catch to the fish market.
- Trash floating and submerged was noted upon every visit to this station.

4. Joe Pattie's 'A Street' stormwater outfall discharges into a daylighted rock lined canal that empties into a protected water inlet mainly used by shrimp and fishing boats to unload their catch directly to the Joe Pattie Fish house. The daylighted rock lined canal is located adjacent to a petroleum tank farm, on the eastern bank. The western bank adjoins the parking lot for fish market. At the time of this study, the site was not suitable for paddlers to enter/exit the water.

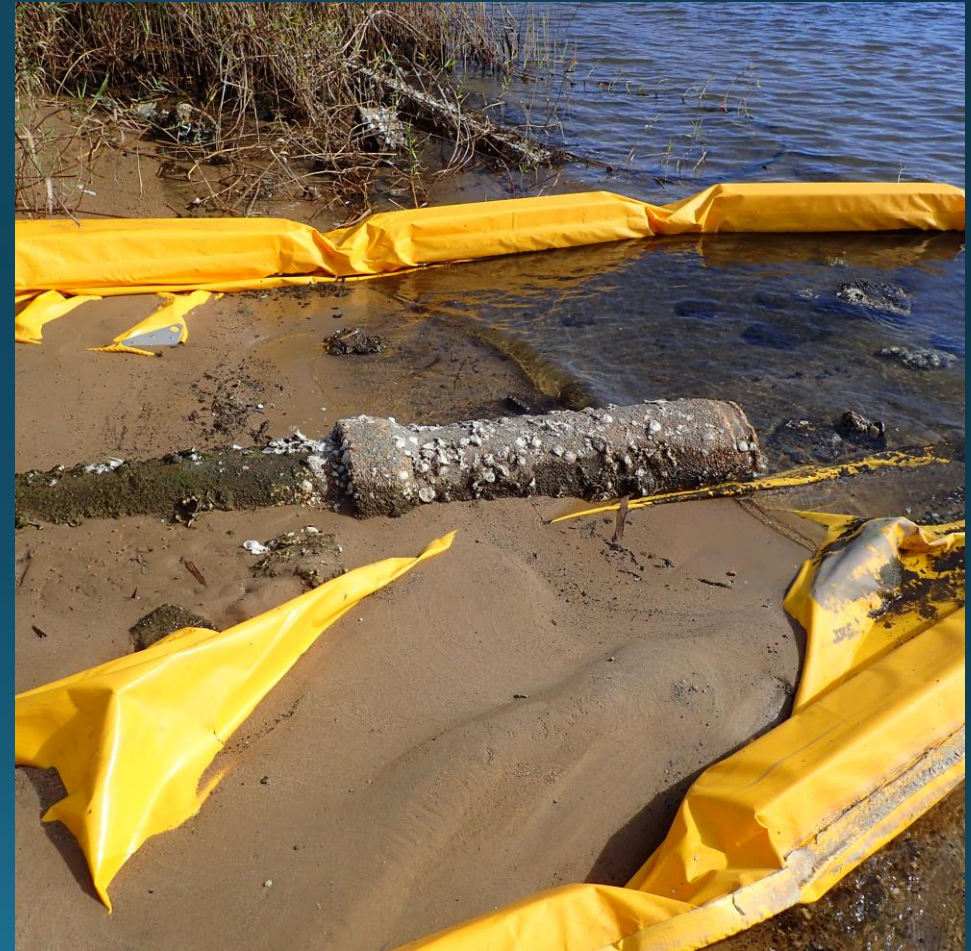
Bayou Texar Boat Launch (Oyster Barn)

- Since the conclusion of the monitoring project, both the restaurant (Oyster Barn) and the boat pier have been demolished.
- This boat launch continues to be a safe and popular site for accessing the water.

10. Bayou Texar Boat Ramp (Stanley and Strong Streets) site is just north of the Cervantes Street Bridge along the eastern shoreline. This location has parking for ~30 vehicles and boat trailers and offers a good ingress and egress for non-motorized and motorized vehicles.
