**Water Quality and Environmental Characteristics of the Upper Perdido, Conecuh, Shoal
and Yellow River Watersheds in 2022**

Technical Report to Pensacola and Perdido Bays Estuary Program

February 28, 2023

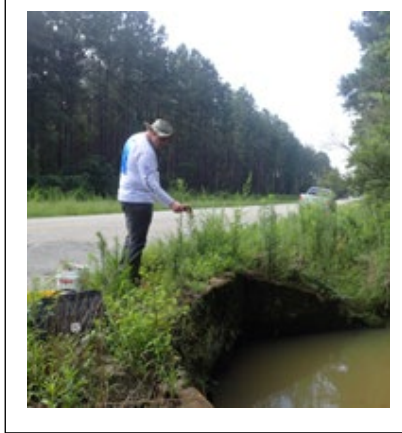
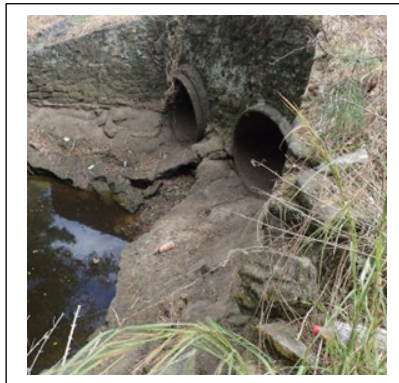
View of culvert (wet)

View of culvert (dry)

Perdido Creek (Figure A2) originates approximately 1.93 km east-northeast from the sampling location on private property. The sampling station is a 2nd-order creek in a rural area surrounded by agriculture (corn) and silviculture (pine) (Figure A3). A sand-mining operation is 1.6 km away from the sampling site. Two small trailer parks are also located within 1.6 km of the site. The creek is bisected by Alabama County Road 1, a paved two-lane road with two 3-ft cement culverts connecting the creek. The riparian zone is fragmented by the culverts. The elevation at the sampling station is 94.2 m and relatively flat. Upstream of the sampling site is a pine plantation. The downstream area is in a natural state and overgrown with grape (*Vitis spp.*) and smilax (*Smilax spp.*) vines. The creek was turbid and not flowing during some of the sampling trips (Figure A4). Frogs, turtles, minnows, and a bluegill were observed. Rocks were observed near the culverts and trash was noted along the roadside and in the creek. Native plants

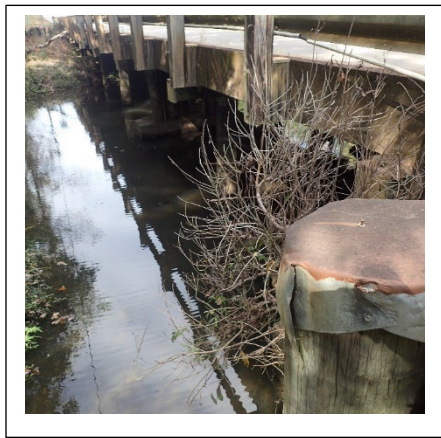
Bridge Structure
(downstream)

natural bottom, which allows the river to meander without obstruction downstream. The elevation at this bridge site is approximately 82.3 m, with the bridge located at a dip in the terrain (Figure A7). When looking downstream, the adjacent road rises 6° to the west and 2° to the east. Road temperatures (41.2°C) were taken during the July 12, 2022 sampling event and were 11°C higher than the adjacent wooded area (30.2°C).

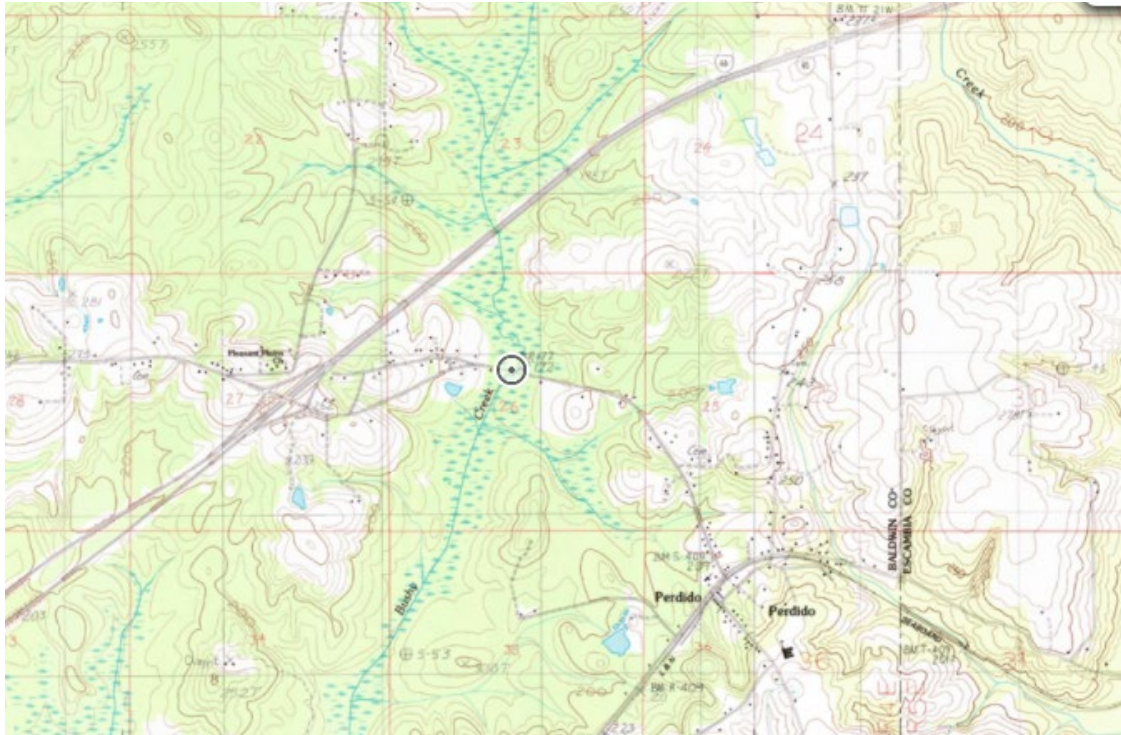
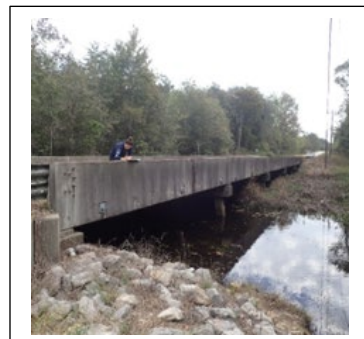
View of Bridge

Figure A9 - Map and Photos of Bushy Creek Sampling Site

Bushy Creek (Figures A8 and A9) is a 3rd-order creek at this station and flows downstream to join Dyas Creek. Dyas Creek is the northernmost tributary entering the mainstem of the river. Most of the landscape within a 1.6 km radius is a combination of natural lands and silviculture. Interstate 65 and County Road 47 are within this 1.6 km radius. The road leading to the bridge is a two-lane paved road and the bridge is cement on cement pilings. Riprap was used to protect the pilings and the creek bank.

The elevation of the creek at this site is approximately 61 m and is accessed by a long bridge (57 m) on a two-lane, paved road. Upstream, a large wetland was fragmented by this bridge, resulting in an area of approximately 18 m (left when looking downstream) with low to no flow, but 19 m (right when looking downstream) with swift flow, which was the location chosen for the sampling site. The creek is shallow (<1 m), has both submerged and emergent aquatic vegetation (Tapegrass, *Vallisneria americana* and Golden Club, *Orontium spp*). It has a sandy bottom and a riparian zone with a mature canopy of trees that keeps the creek shaded (Figure A9).

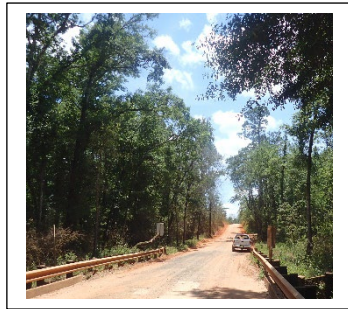
Figure A12 - *Maps and Photos of Hollinger Creek Sampling Site*

our team observed trash, including mattresses, tires, and several plastic bags, which may have been household debris, thrown near the creek banks. Hollinger Creek at Still Road was 1.2 m deep and had a good flow rate. A large bay swamp with well-vegetated banks was fragmented by the bridge crossing (Figure A12). Near the road, mainly along the disturbed edges, invasive species including *Albizia spp* (mimosa), *Ligustrum spp* (privet), and *Ligodium spp* (Japanese climbing fern) were observed.

Bridge in Still Road

Looking Downstream

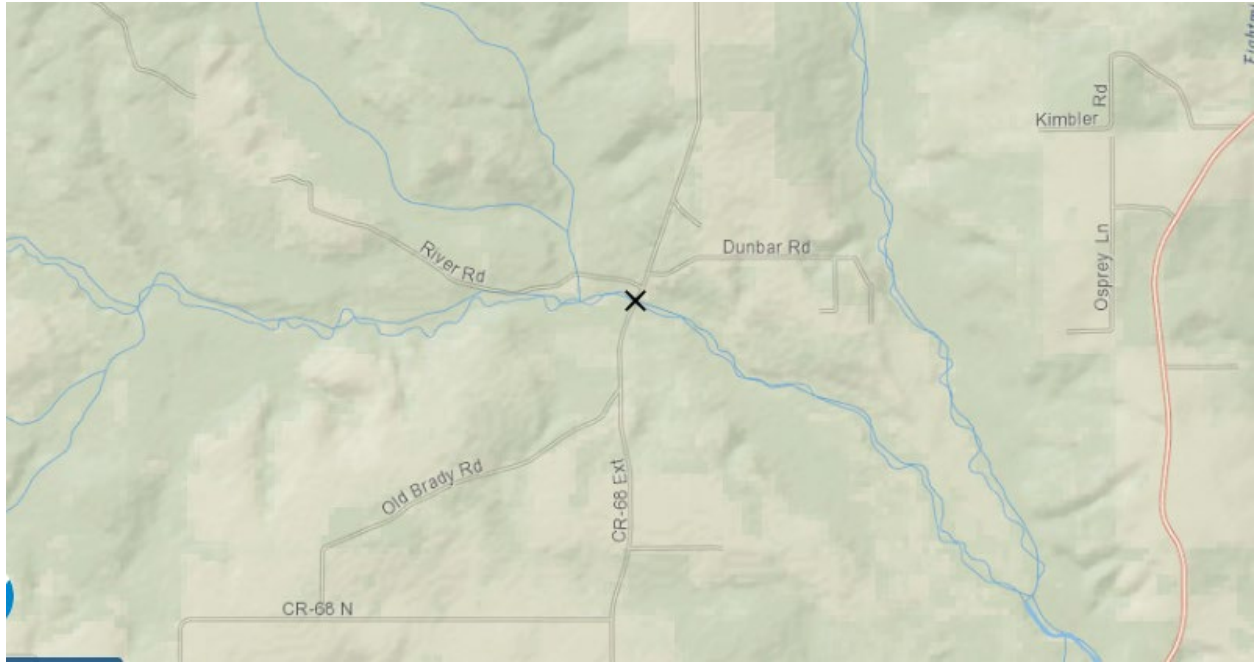
Figure A13 - Styx River, Perdido Watershed, Lat/Long 30.66405 N, -87.63924 W, Baldwin County, AL

The Styx River (Figure A13) converges with Hollinger Creek approximately 3.2 km downstream from this sampling site. Prior to joining Hollinger Creek, the Styx River is a 5th-order system which also forms just south of Bay Minette. Roughly 40% of the watershed in a 1.6 km radius is agricultural (corn and soybean), whereas the remaining approximately 60% is comprised of natural lands.

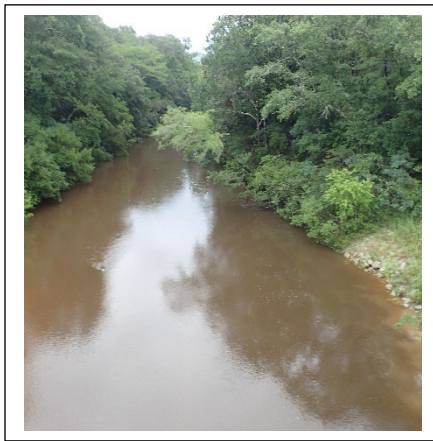
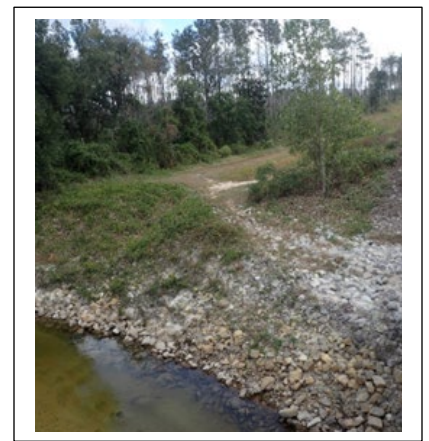
Figure A14 - Map and Photos of Styx River Sampling Site

In areas that have been cleared in the vicinity of the river, a substantial riparian buffer has been maintained. Small sand pits were observed throughout the area where sand mining may have been attempted in the past. The convergence of the Styx River and Hollinger Creek represents the largest tributary and drainage system entering the Perdido River from the west. The elevation at this site is approximately 20 m above sea level and the stream velocity was high. The river was muddy during every visit to the site. Approximately 10.5 km west-northwest from the sampling station is a manmade lake (impounded 1st- and 2nd-order streams), which is adjacent to Steelwood Country Club. A power line easement runs parallel to the bridge on the upstream side and all the banks of the river at the bridge and easement were lined with large amounts of riprap (Figure A14). Upstream and downstream, outside of the bridge disturbance, the riparian vegetation was dominated by *Quercus spp* (oak), *Pinus spp* (pine), *Acer spp* (maple), *Liquidambar spp* (sweetgum), *Magnolia spp* (sweet bay), and *Nissa spp* (water tupelo).

Looking Upstream

Looking Downstream

Banks of the Styx River

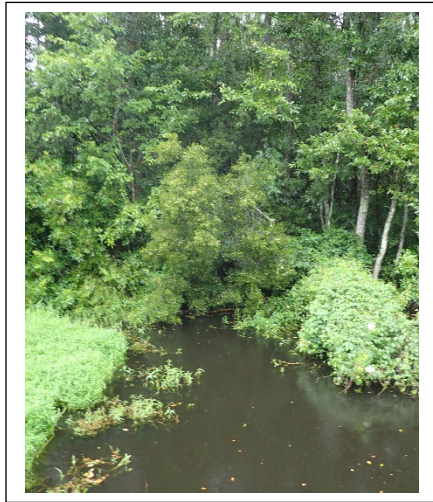
Figure A17 - *Photos of the Blackwater River Sampling Site*

Looking Upstream

Looking Downstream

Looking towards bridge

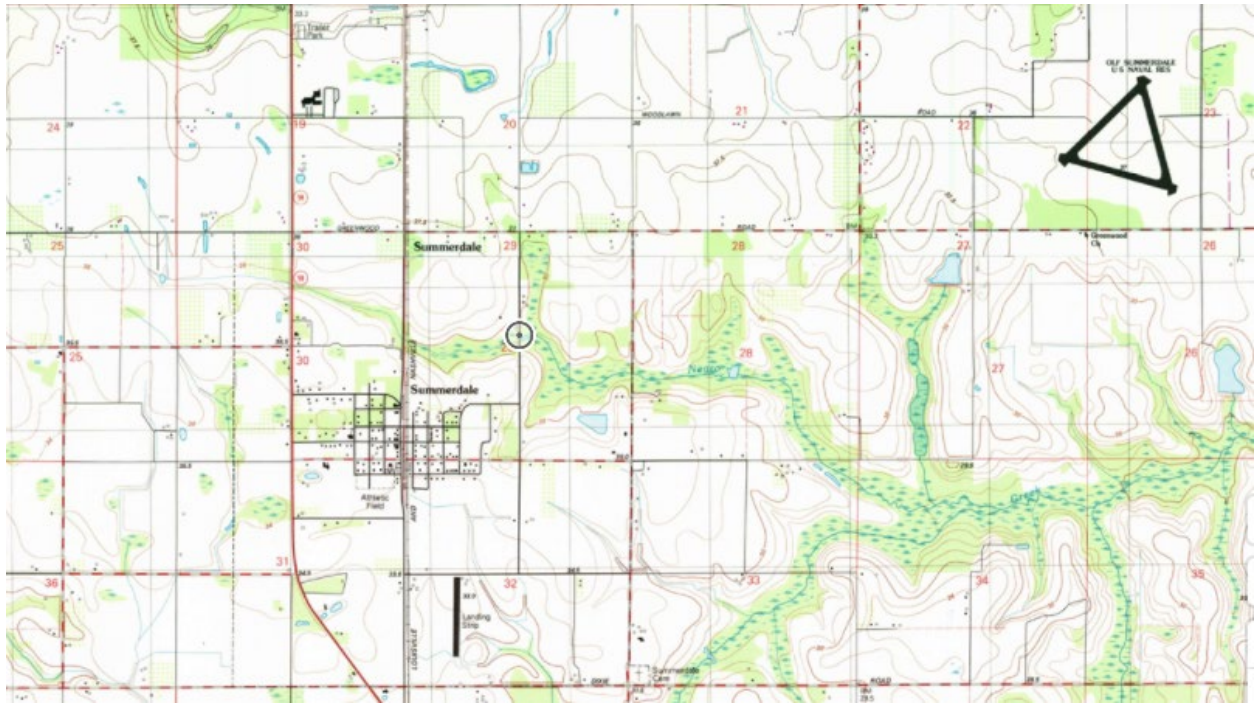
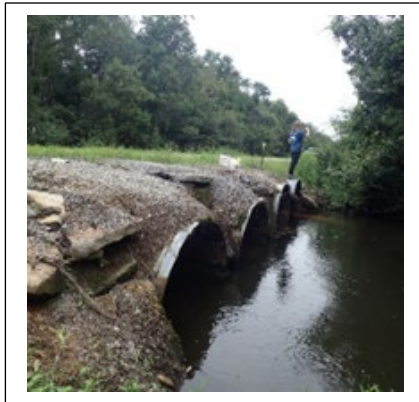
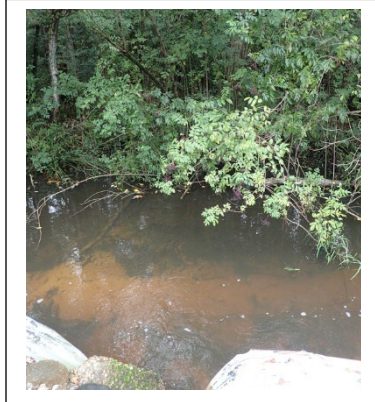
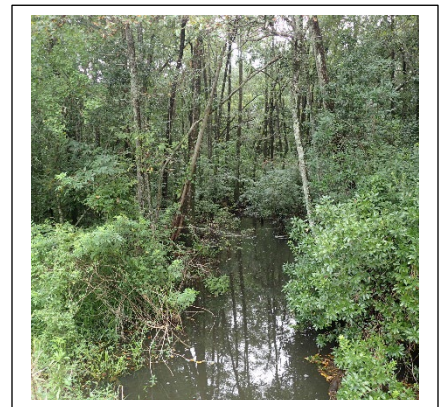
Figure A19 - Map and Photos of Negro Creek Sampling Site

Downstream Side of Road

Creek Channel

Looking Upstream

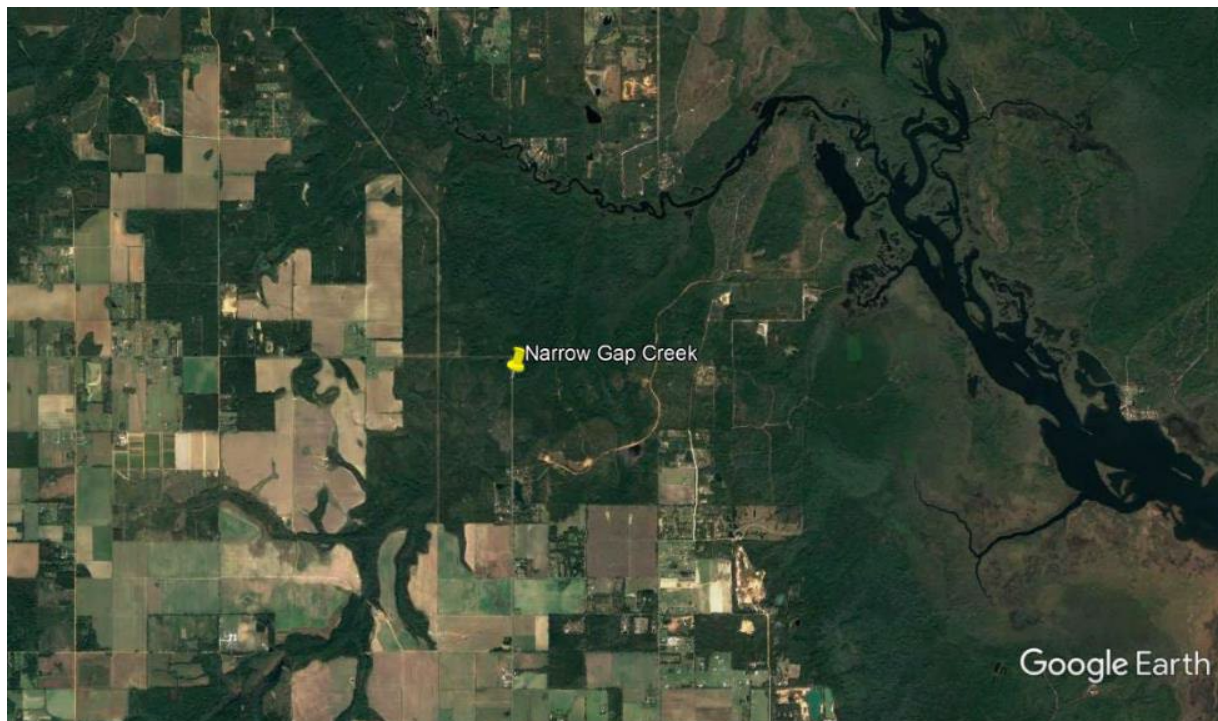
Figure A20 - *Narrow Gap Creek, Perdido Watershed, Lat/Long 30.46336, -87.48052, Baldwin County, Alabama*

The Narrow Gap Creek site (Figure A20) is located within conservation lands (Forever Wild Land Trust) and is a 3rd-order creek. The creek originates roughly 5 miles west-southwest from the sampling station and flows into Helton Bay and Juniper Swamp before flowing into the lower Blackwater River. Negro Creek enters the Blackwater River approximately 9.7 km upstream from this site. The elevation at this site is approximately 15 m above sea level. Roughly 95% of the area within a 1.6-km radius is natural land. A small culvert (approximately one foot in diameter) located on the southeast side of the road and creek flows over rocks before entering the creek (Figure A21). The tree canopy was mature and in excellent shape. The forest appears to be on a fire rotation cycle, with evidence of a burn within the last two years observed in a nearby upland area.

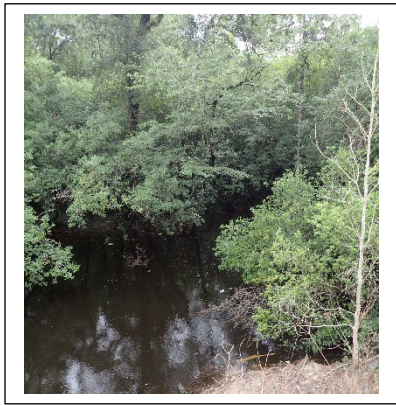
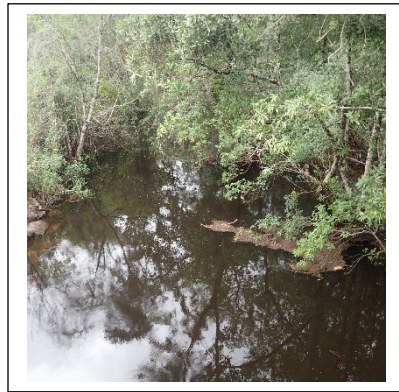
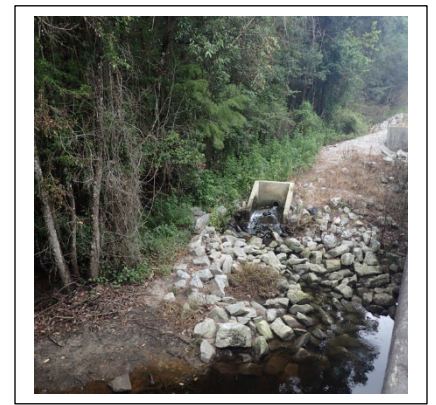
Figure A21 - *Map and Photos of Narrow Gap Creek Sampling Site*

Looking Upstream

Looking Downstream

Culvert

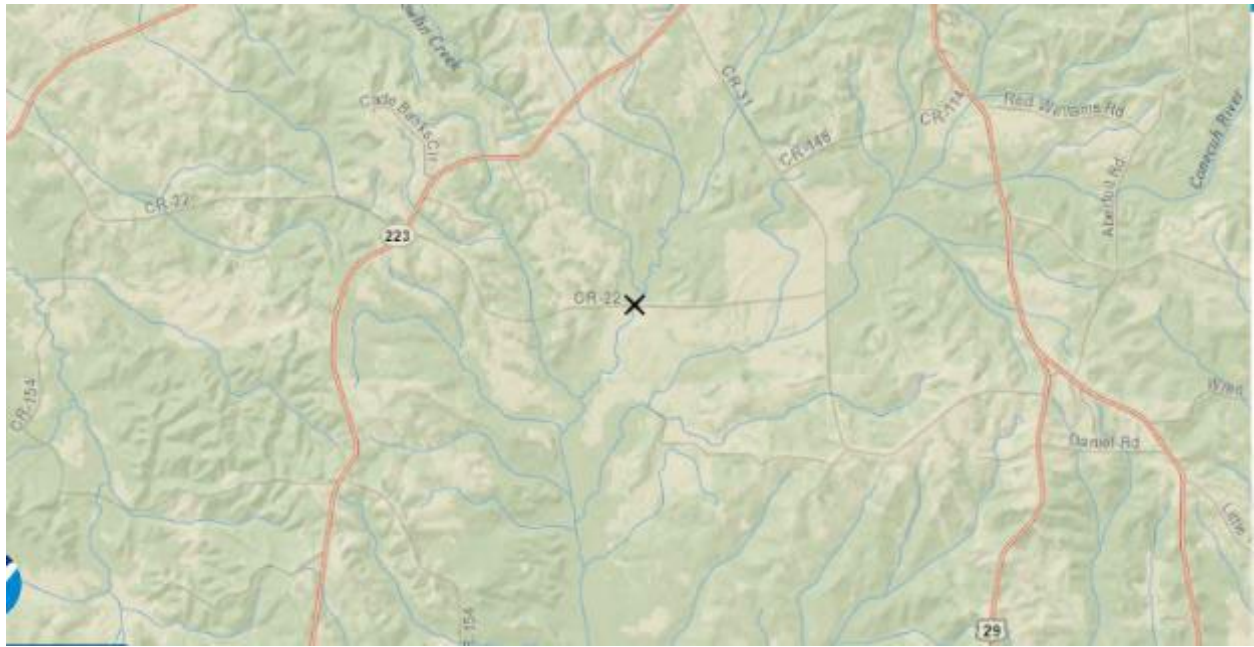
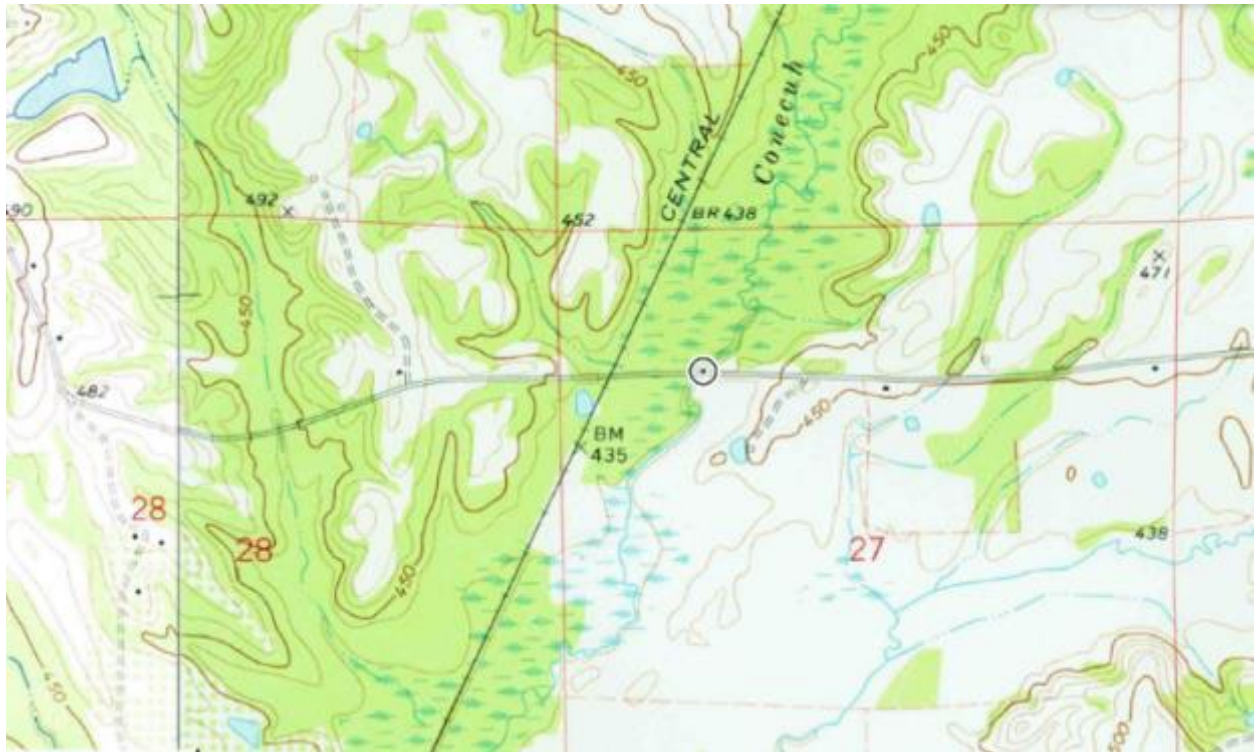
Figure B3 - Maps of Conecuh E Sampling Site

The bridge is 58 m in length. The left access road to the bridge is 272 m to the highest point, with a slope of 5° (when looking downstream). The right access road is 747 m to the highest point, with a slope of 4°. The bridge has a natural bottom and is 3 m in depth, which may be a result of the volume of water moving through this area. The upstream side of the bridge is a large, low-lying, wetland area with three distinct channels (originating from the west, north, and east) and small, elevated, vegetated areas in between each channel. The upstream and downstream waters were quiet during the five visits to the site. On each visit, more vegetation from the downstream banks was growing towards the middle of the channel. By the last visit the vegetation had almost grown together to cover the water. Ample duckweed filled the interstitial areas (Figure B4).

The area surrounding this station has a few small, private farmsteads and one large, agricultural business growing ornamental plants for large box stores (BonniePlants.com). A series of greenhouses are located west-southwest of the sampling station.

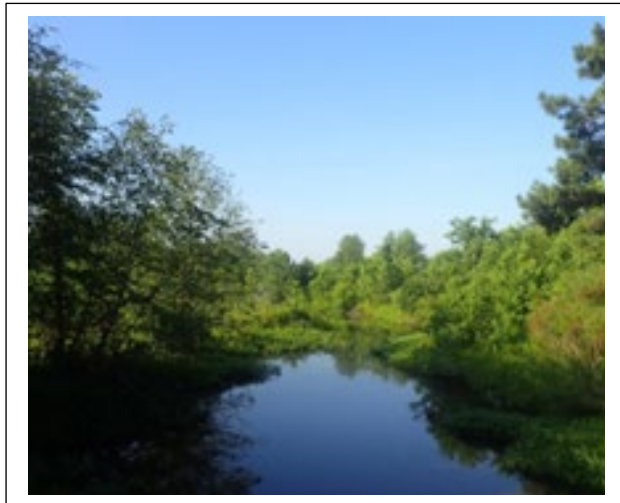
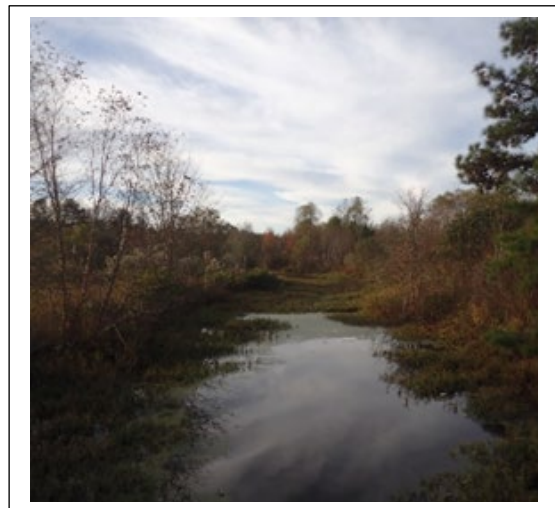
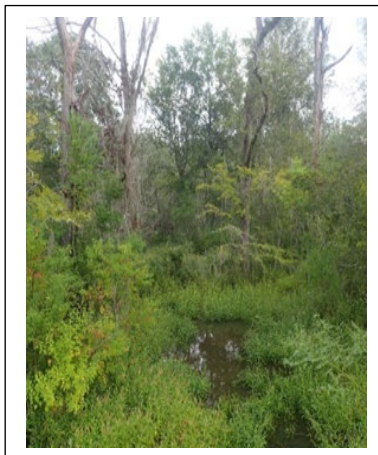
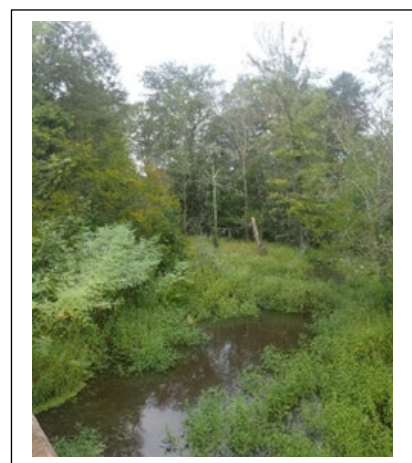
Figure B4 - Photos of Conecuh E Sampling Site

Looking Downstream June 2022

Looking Downstream November 2022

Upstream looking west

Looking upstream from middle

Upstream looking east

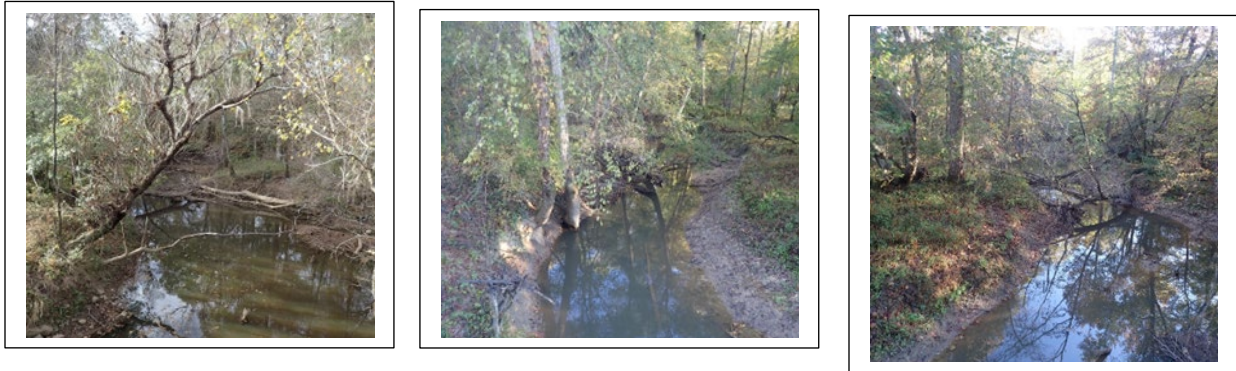
Figure B7 -Photos of Conecuh D sampling site

The bridge is supported by six cement pilings, which are both in the river and on the banks. Rocks were observed near the bridge supports but not elsewhere. The elevation at this site is 118 m (above sea level) (Figure B7).

View Upstream

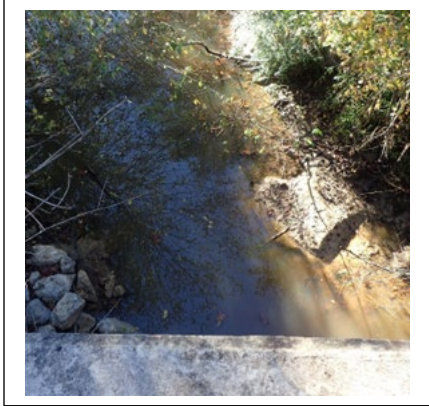
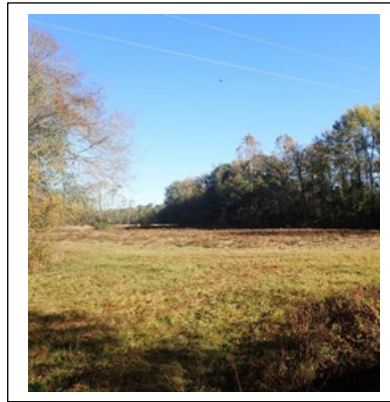
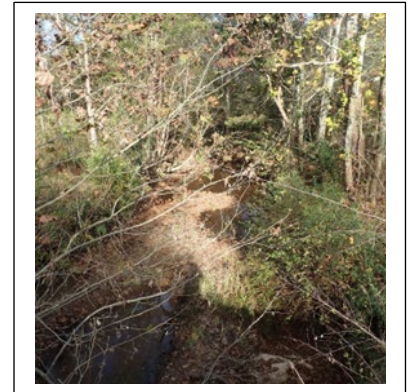
**Figure B10** - *Photos of Log Creek Sampling Site*

Looking downstream

Adjacent farm field

Looking upstream

The creek is filled with sediment and, on the last two visits, had almost no flow. The farm fields upstream and downstream were cleared, leaving virtually no vegetative buffer (Figure B10). Cattle and horses were observed and smelled at this site.

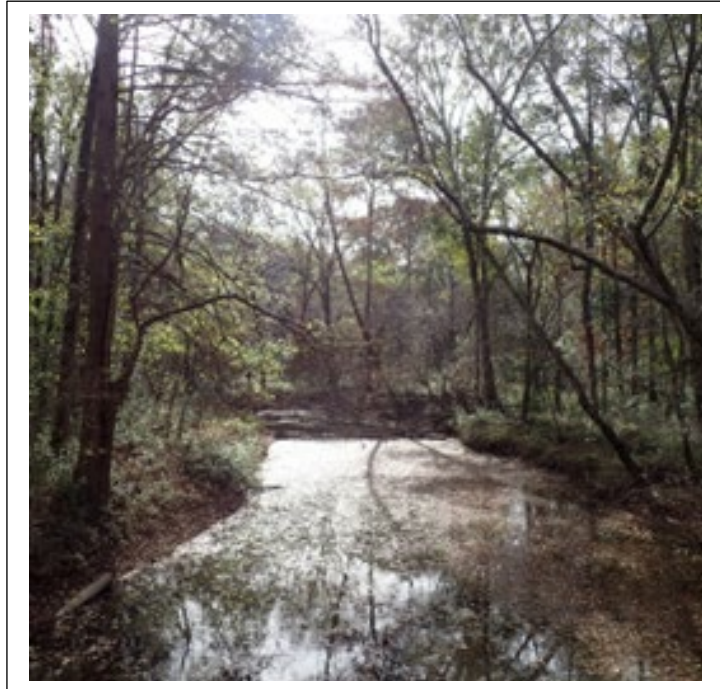
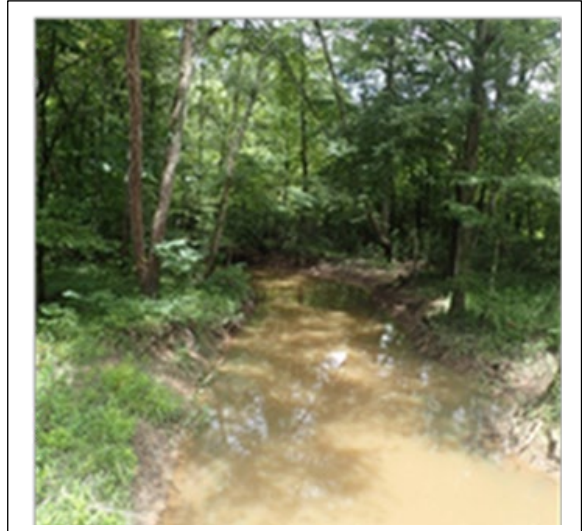
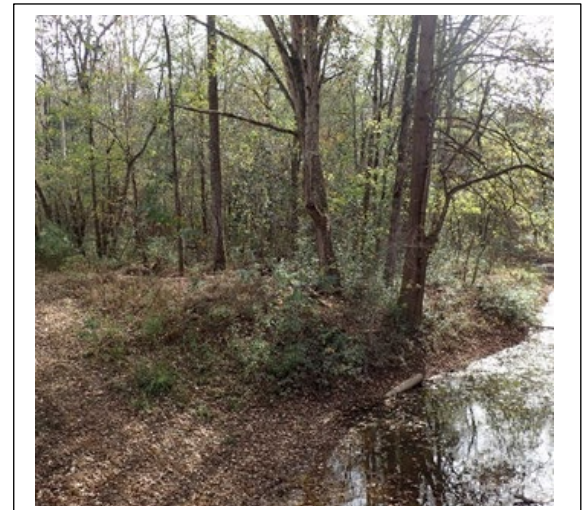
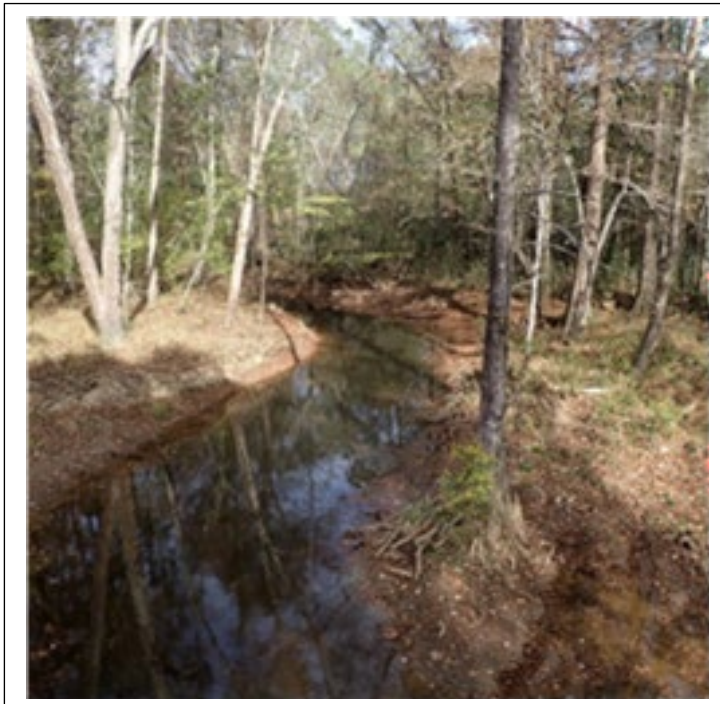
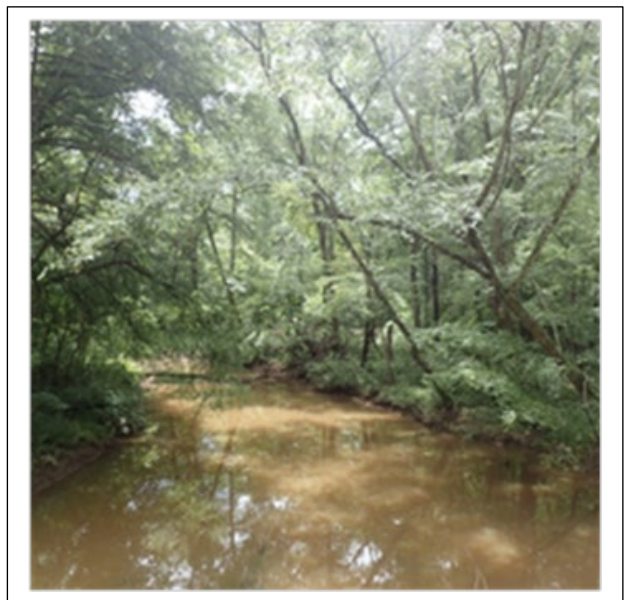
Figure B22 - *Photos of Patsaliga Creek Upper Sampling Site*

The photographs in Figure B22 were taken during the sampling efforts and characterized the creek as the area began to experience drought conditions. Column 1: top picture is upper Patsaliga Creek looking downstream, bottom picture is a view of the creek looking upstream during dry weather. Column 2: top picture is the same upstream view following a rain event, middle picture shows the condition of the creek bank during low flow (note the bank is stable, no rocks, and the tree roots are stabilizing the system), and bottom picture shows the creek (looking upstream) during summer with a mature canopy and well shaded.

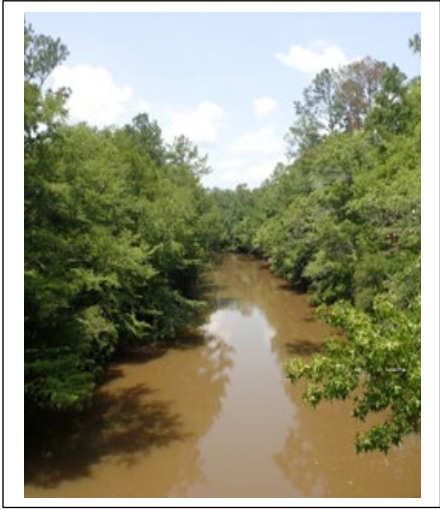
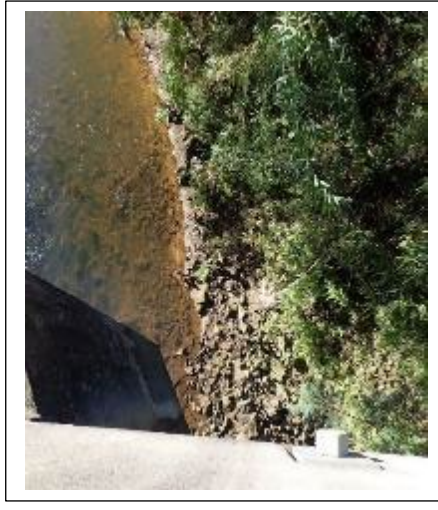
**Figure B25 - Photos of Patsaliga Creek Lower Sampling Site**

Looking Upstream

Looking down at roots during drought

Looking downstream

The creek is very shallow and has obvious riffles visible both upstream and downstream. The creek appears to have a bedrock of limestone, which could not be verified since safe access could not be determined. The banks along the creek are well vegetated with mature cypress, oaks, and red maples. The root network along the banks became visible when our sampling period entered a drought and was observed to be grown together with ferns filling the voids (Figure B25).

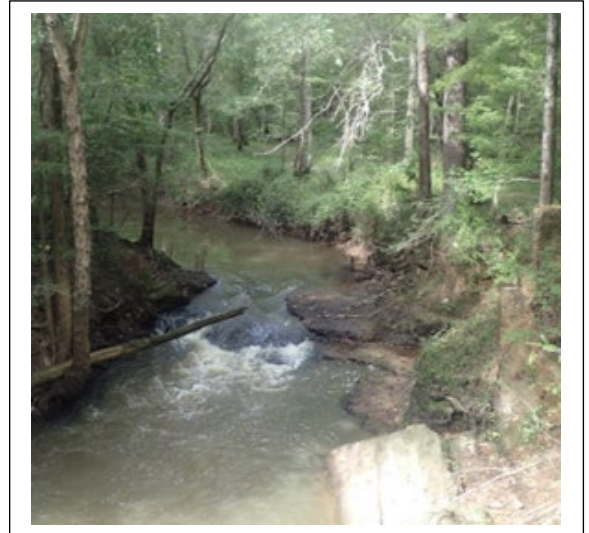
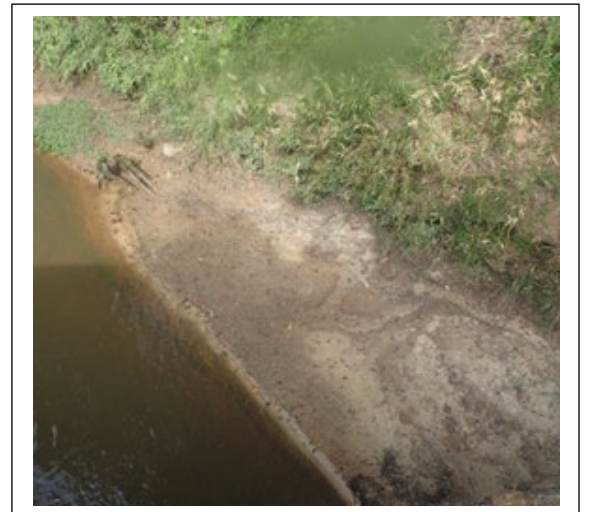
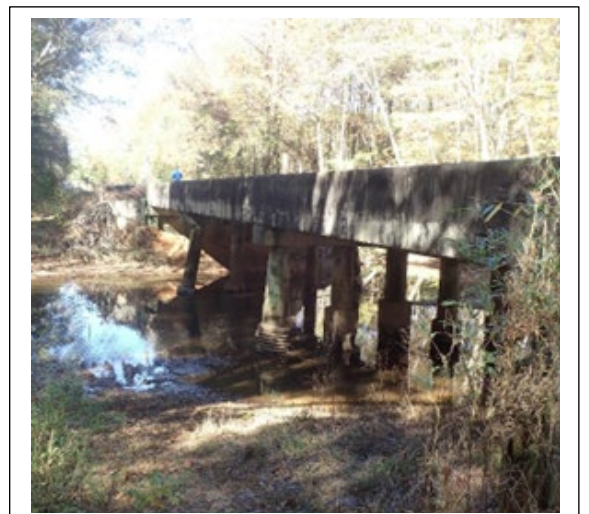
Figure B28 - *Photos of Persimmon Creek Sampling Site*

The photographs in Figure B28 were taken during the sampling efforts and characterized the creek as the area began to experience drought conditions. Column 1: top picture is upper Patsaliga Creek looking downstream, bottom picture is a view of the creek looking upstream following a rain event. Column 2: top picture is the same upstream view during low water (note the waterfall which is flowing over the remains of an old cement bridge), middle picture shows the condition of the creek bank during low flow (note the bank is stable and no rocks have been used to stabilize the system), and bottom picture shows the bridge structure with ample room to accommodate flood stage without constriction.

Persimmon Creek station is in a rural, wooded, low-lying floodplain accessed by a two-lane paved road. The bridge is cement, with metal pillars embedded in cement blocks placed on the creek bed. The river bottom is natural. Upstream, the remnants of an old bridge are visible, and a flat portion of cement (from the old bridge) is positioned so water from upstream flows over it and creates a waterfall before flowing under the new bridge. The bridge is 37 m in length, while the creek channel is 19 m (bank-to-bank). Looking downstream, the bridge approach from the left is 252 m to the nearest hilltop with a 6° slope. The right approach is virtually flat.

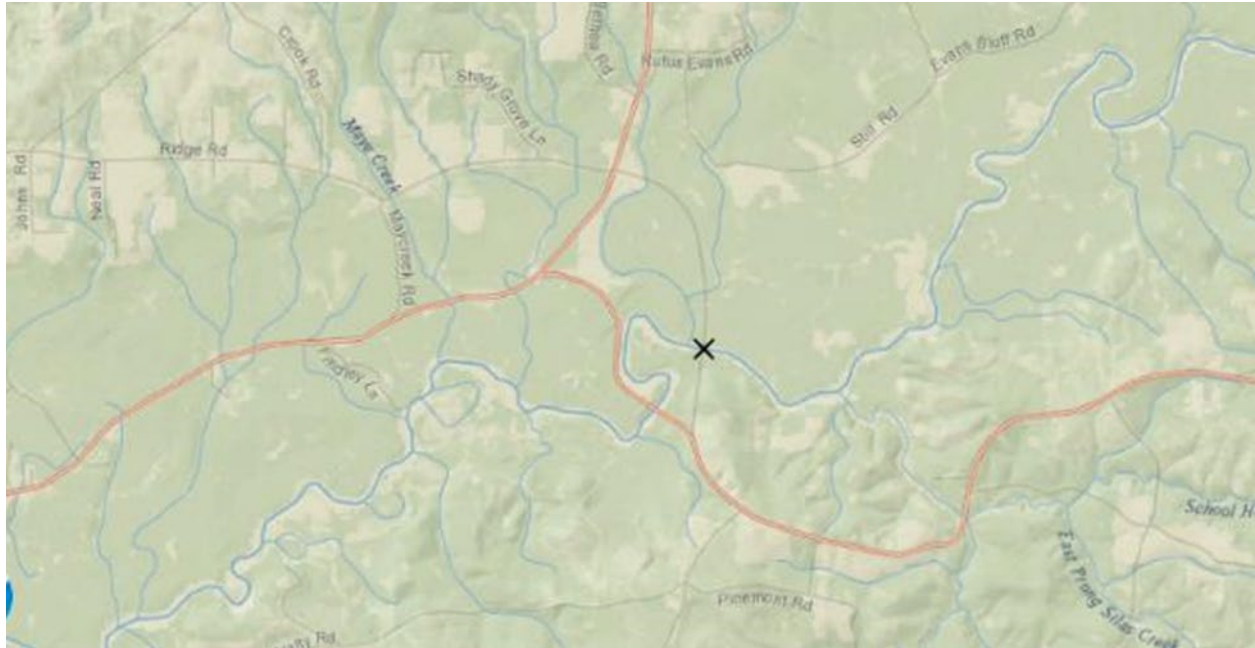
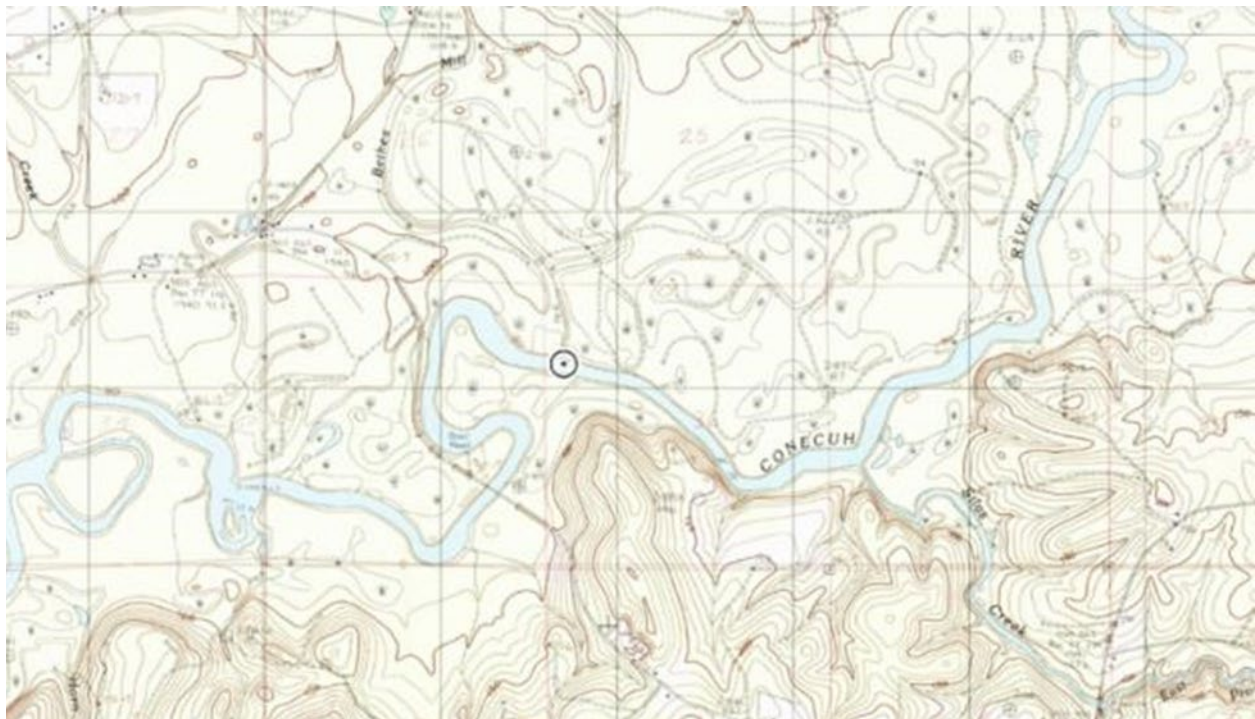
Figure B30 – *Maps of Conecuh B*

The Conecuh River is a 6th-order stream at station Conecuh B (Figure B29). The elevation at this site is 29 m above sea level. The floodplain extends almost 1.6 km from the mainstem in each direction. Hwy 4 crosses the river as a two-lane, paved road, with an approximately 300 m bridge that spans the river and parts of the floodplain (Figure B30). The river is approximately 75 m wide at the bridge and was accessible by sampling at a boat launch.

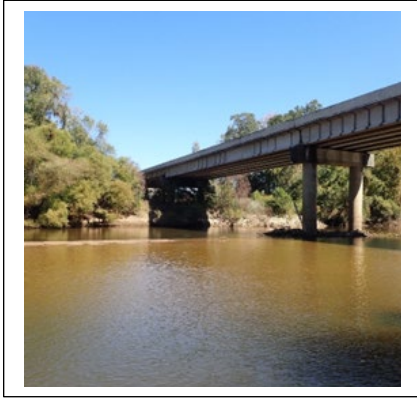
Figure B31 - Photos of the Conecuh River B Sampling Site

The site has a significant amount of sediment accumulating above and below the station, including a sandbar that was forming in the middle of the main channel and became visible during low flow. River birch have become established along the far bank during the last period

of low water levels. Other vegetation noted included maples, willows, oaks, *Platanus spp.* (sycamores), *Liquidambar spp.* (sweet gum), *Chamaecyparis spp.* (cedars), *Populus spp.* (poplars), and pines. The bridge is very high with the approaching roadways at a lower elevation than the bridge itself (Figure B31).

View across river, note sandbar

View upstream

View downstream

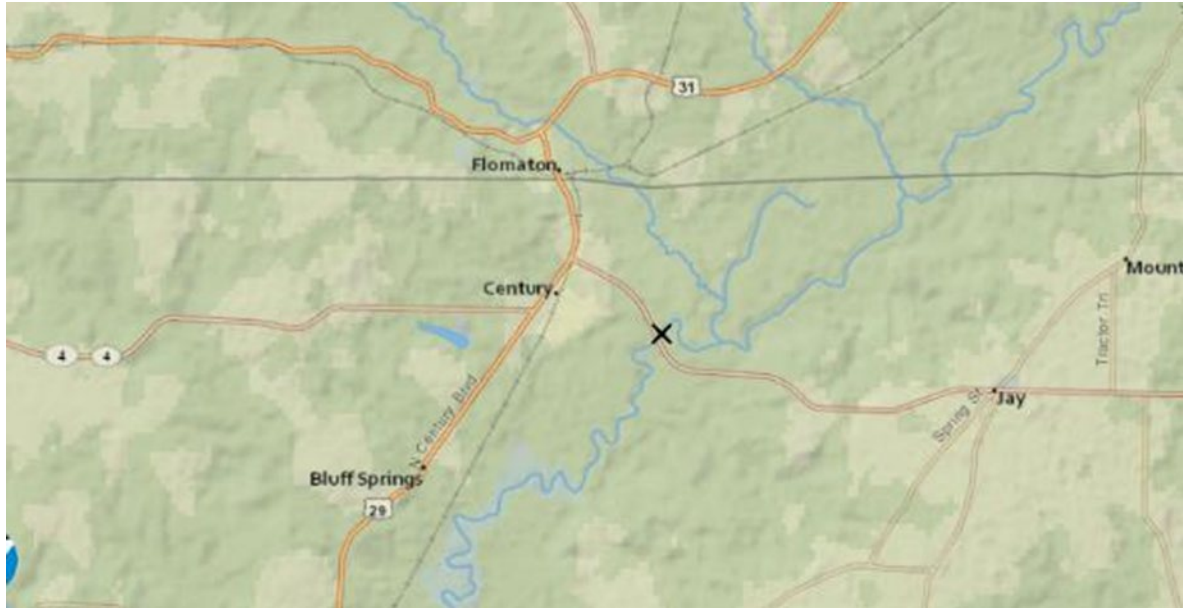
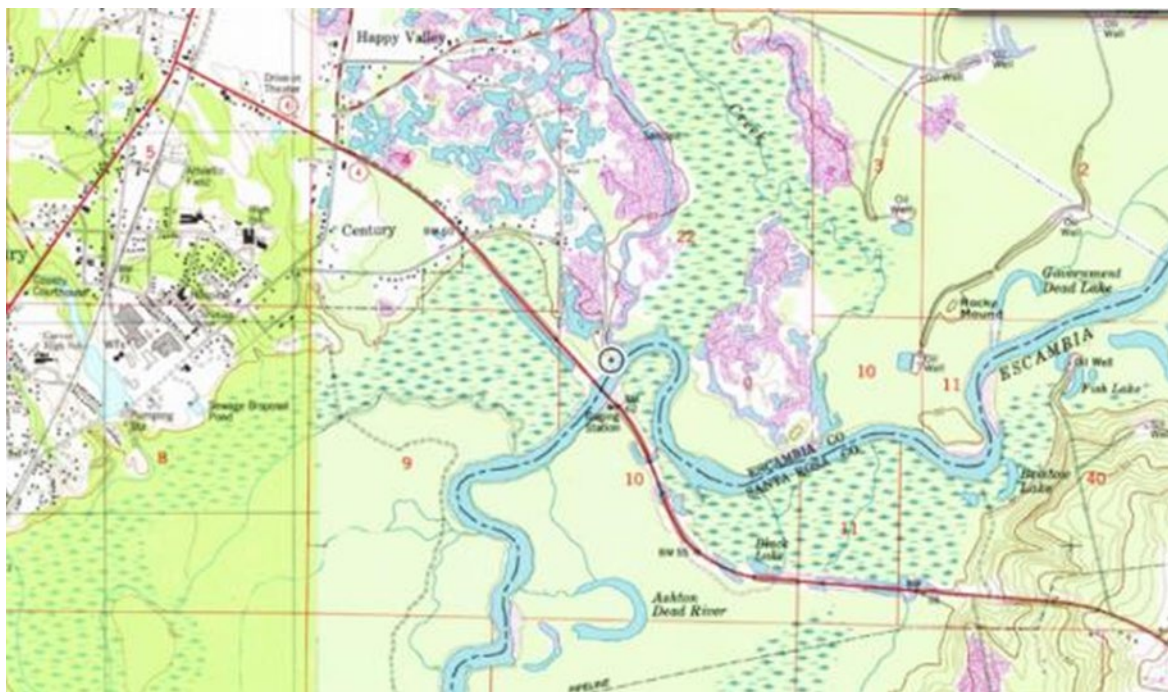
Figure B33 – *Maps of Conecuh River A*

The nearest communities are Century, FL and Flomaton, AL (Figure B33). Both communities are located within 4.8 km west-northwest and northwest of the sampling station.

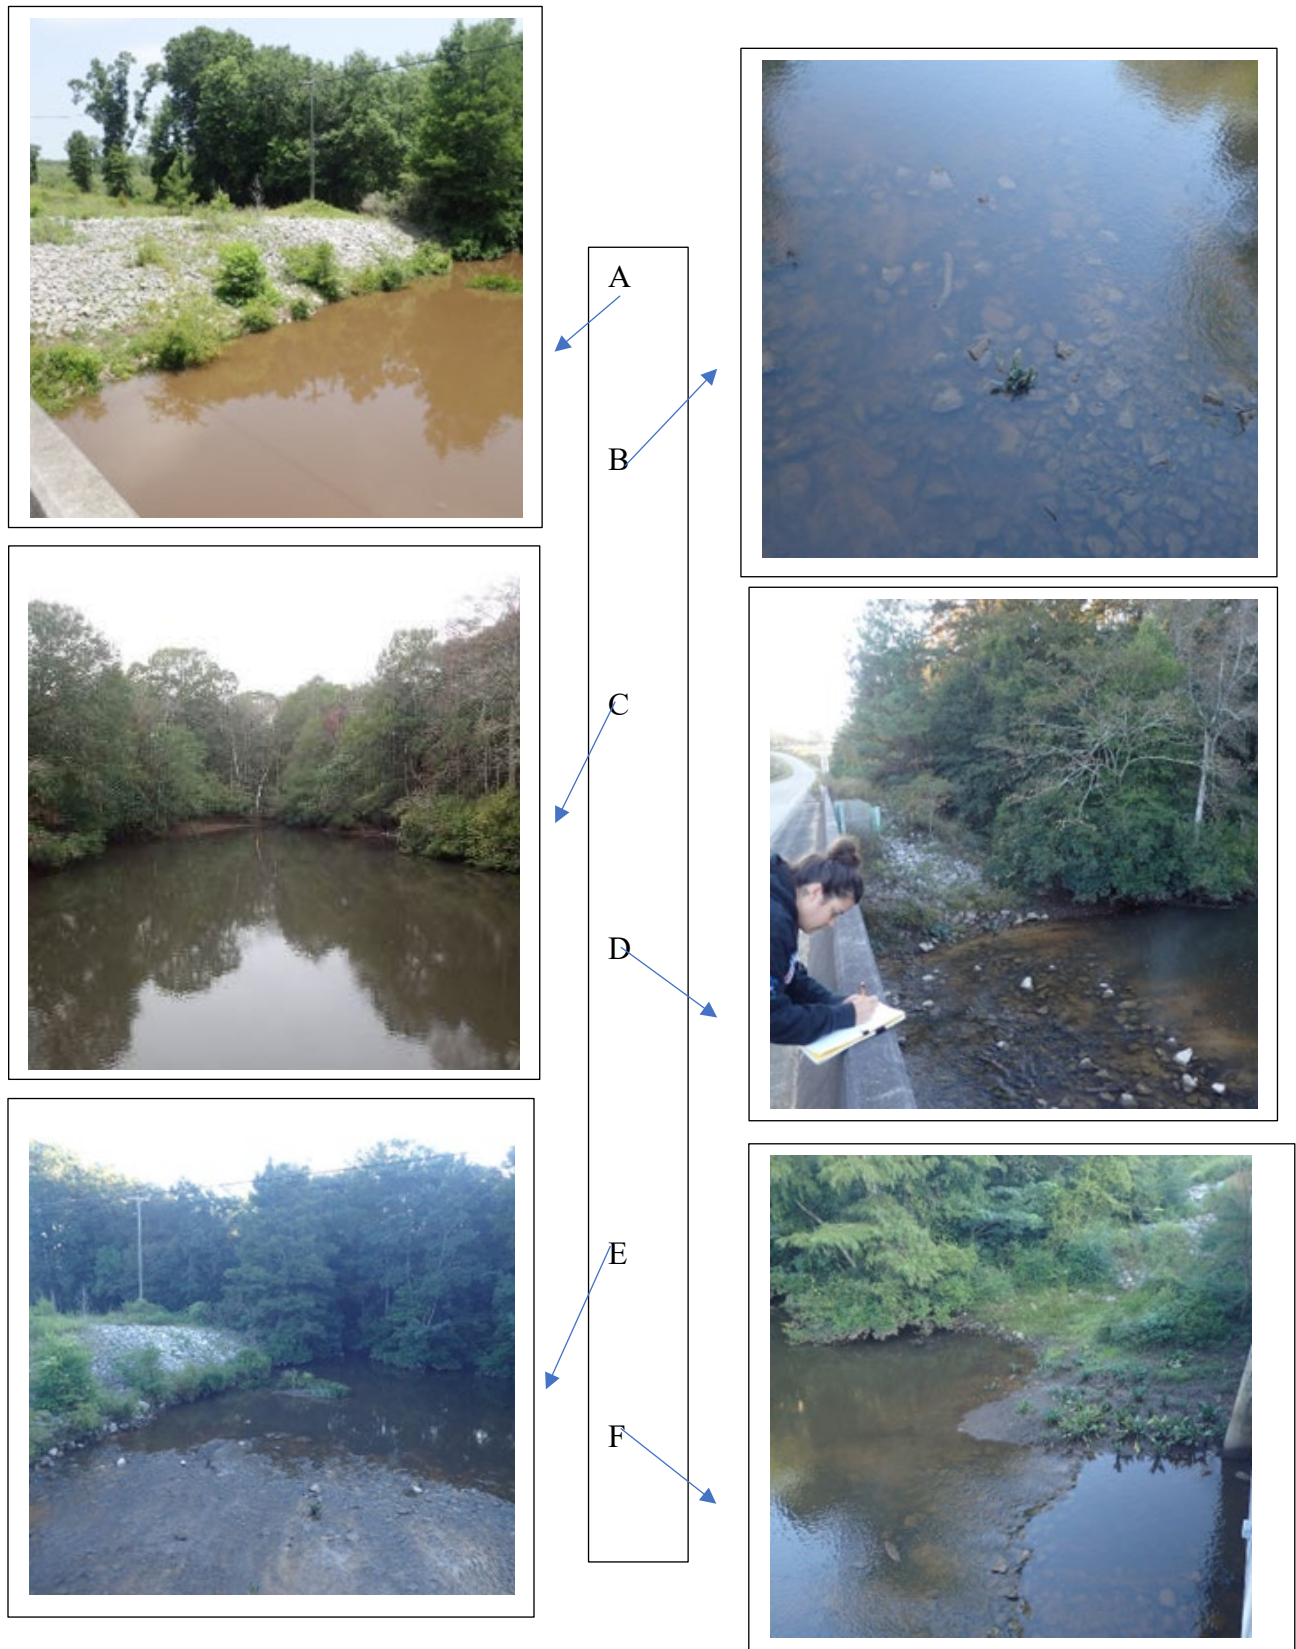
Figure C3 -Photos of Lightwood Knot Creek

Figure C3 illustrates site conditions during the study. Photo A, looking upstream from the bridge, note the number of rocks used to stabilize the bank; the creek was shallow enough to see the creek bed was lined with rocks (B); looking downstream from the bridge (C); collecting data (D); upstream side of bridge during low flow conditions (E); and vegetation taking root on mud bank during low flow conditions (F).

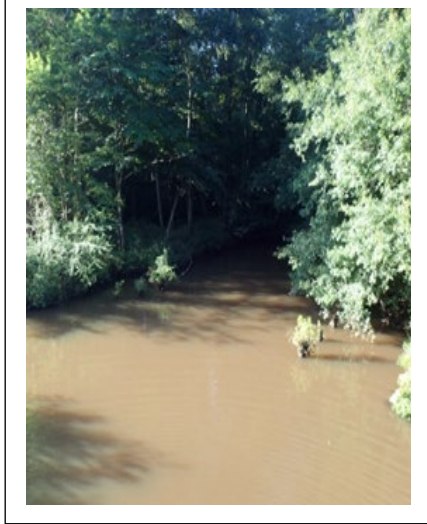
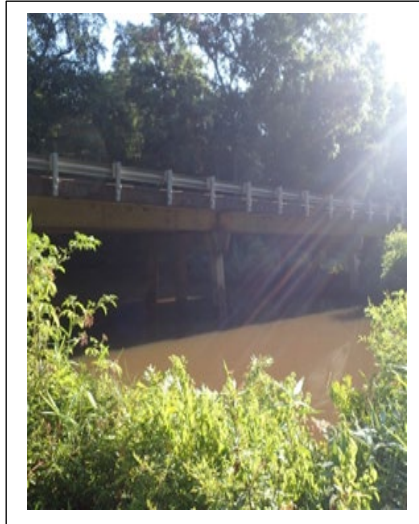
Figure C5 -Photos of Poley Creek

Looking downstream (note old bridge pilings with vegetation in the water)

View of the bridge

Looking upstream

The bridge span is 59m in length and is serviced by a paved 2-lane road. The bridge is cement with 3 cement pilings, and the creek has a natural bottom. Remnants of an old wooden bridge can be seen on the downstream side (Figure C5). While looking downstream, the left bridge approach is $\sim 8^\circ$ while the right approach does not appear elevated and the road curves out of sight.
