**Water Quality and Environmental Characteristics of the Upper Perdido, Conecuh, Shoal
and Yellow River Watersheds in 2022**

Technical Report to Pensacola and Perdido Bays Estuary Program

February 28, 2023

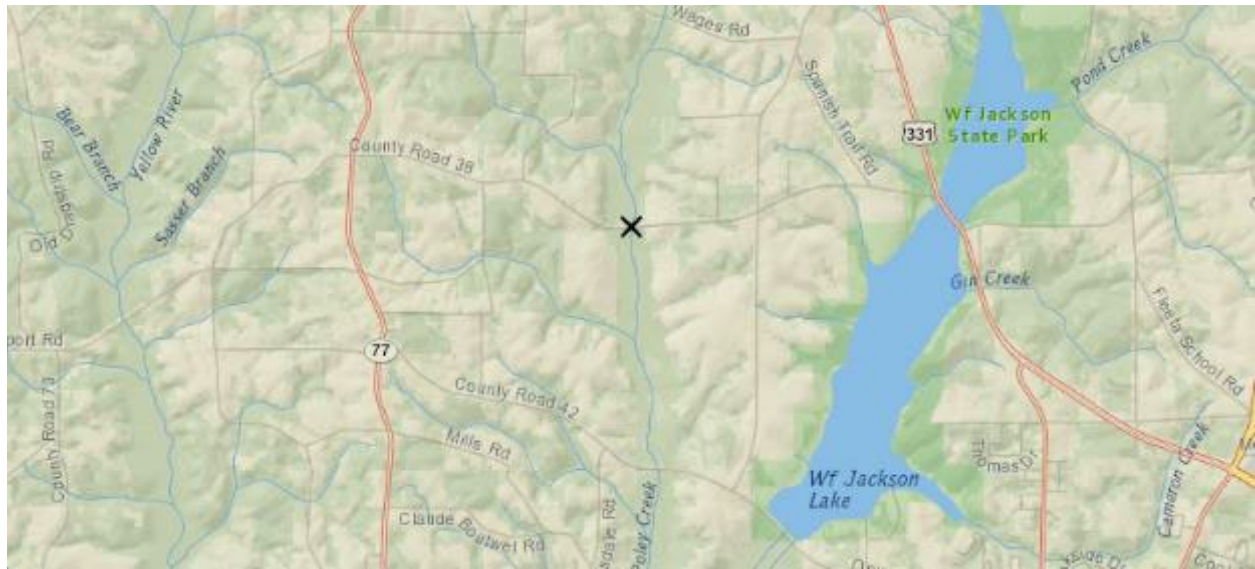
Figure C5 – Maps of Poley Creek

Outside of the riparian zone and within a mile of the sampling station are several small farmsteads, three of which to the east have impounded smaller creeks to make lakes on their property (Figure C5). Several large chicken houses are located southeast of the sampling station, also within a mile of the site.

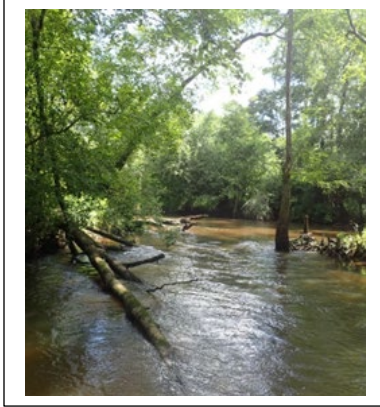
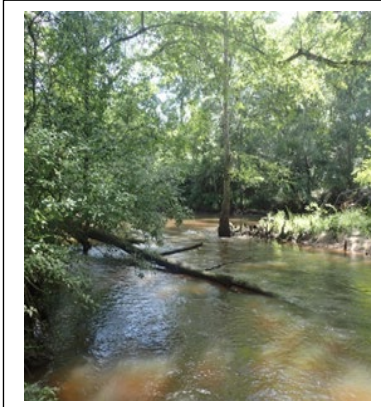
Figure C8 – *Photos of Yellow River Upper station*

flows around an island which appears to be established in the remains of a log jam, perhaps the remnants of the old wooden bridge (Figure C8).

Looking upstream

Looking towards small island

Looking downstream

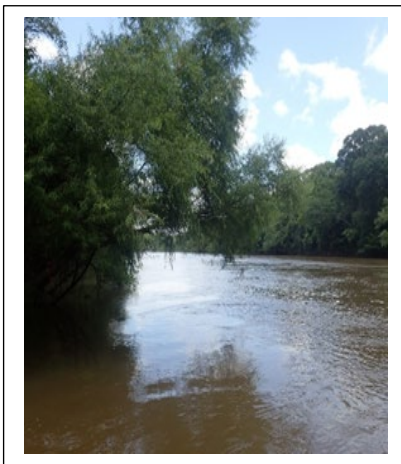
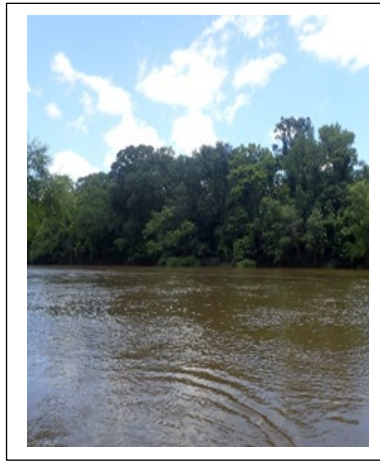
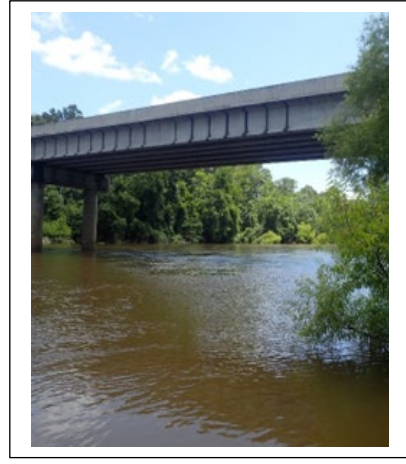
Figure C10 - *Photos of Yellow River Lower station*

At this station, the Yellow River is at an elevation of 39 km and except for ~3.2 km, borders the Conecuh National Forest to the west from the previous Yellow River Station. The Yellow River at Given's Bridge is a 5th order system, and the bridge spans a length of 104m of river and floodplain (Figures C9 and C10). The river is ~33m wide and was accessed from the shore at a boat launch. Very little woody material was observed in the system at this site.

View looking downstream

View looking across the river

View looking upstream

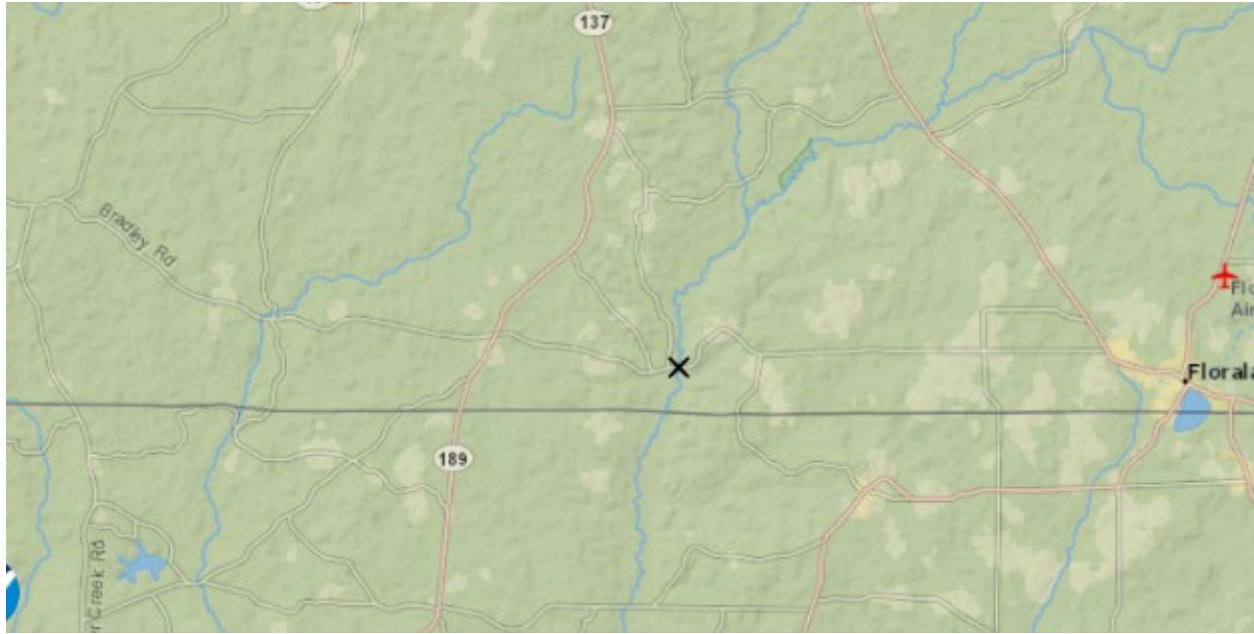
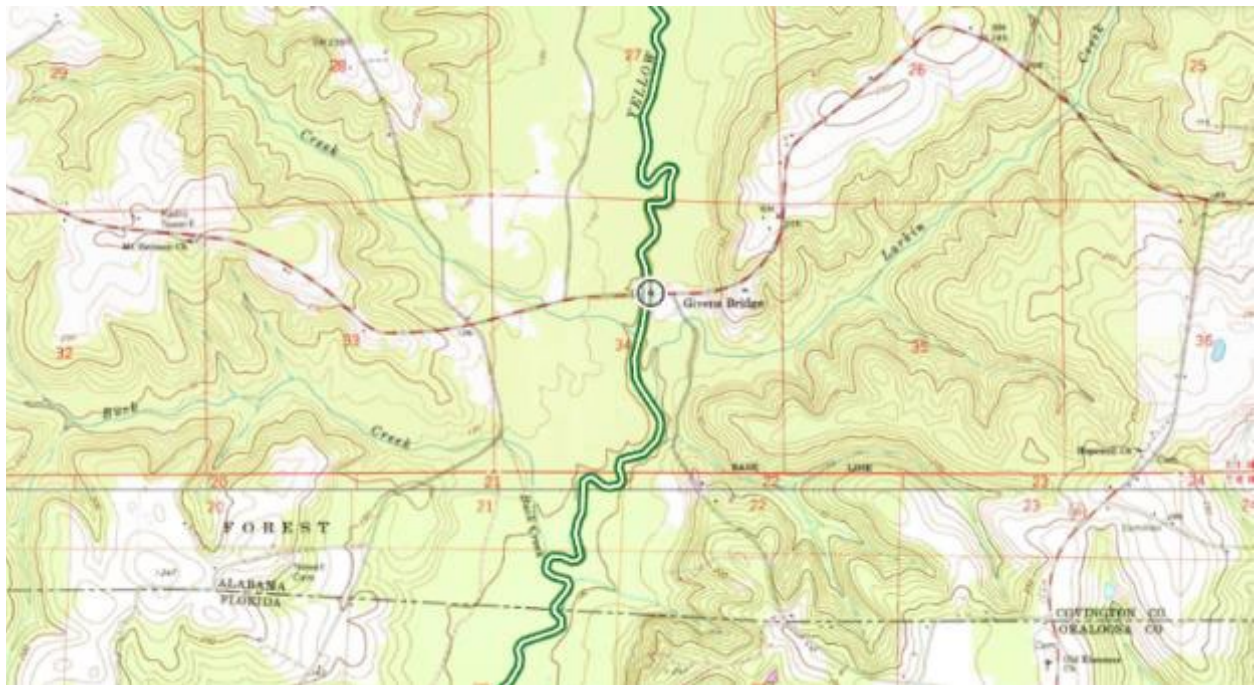
Figure C11 – *Maps of Yellow River Lower station*

Within 1.6 km of the site, the area remains rural, but it should be noted that between the upper and lower Yellow River Stations, along Hwy 4, a large, forested area has been cleared and is being converted to solar panels and a power-grid station. Hwy 4 is located ~ 1.6 km north of the FL-AL state line (Figure C11).

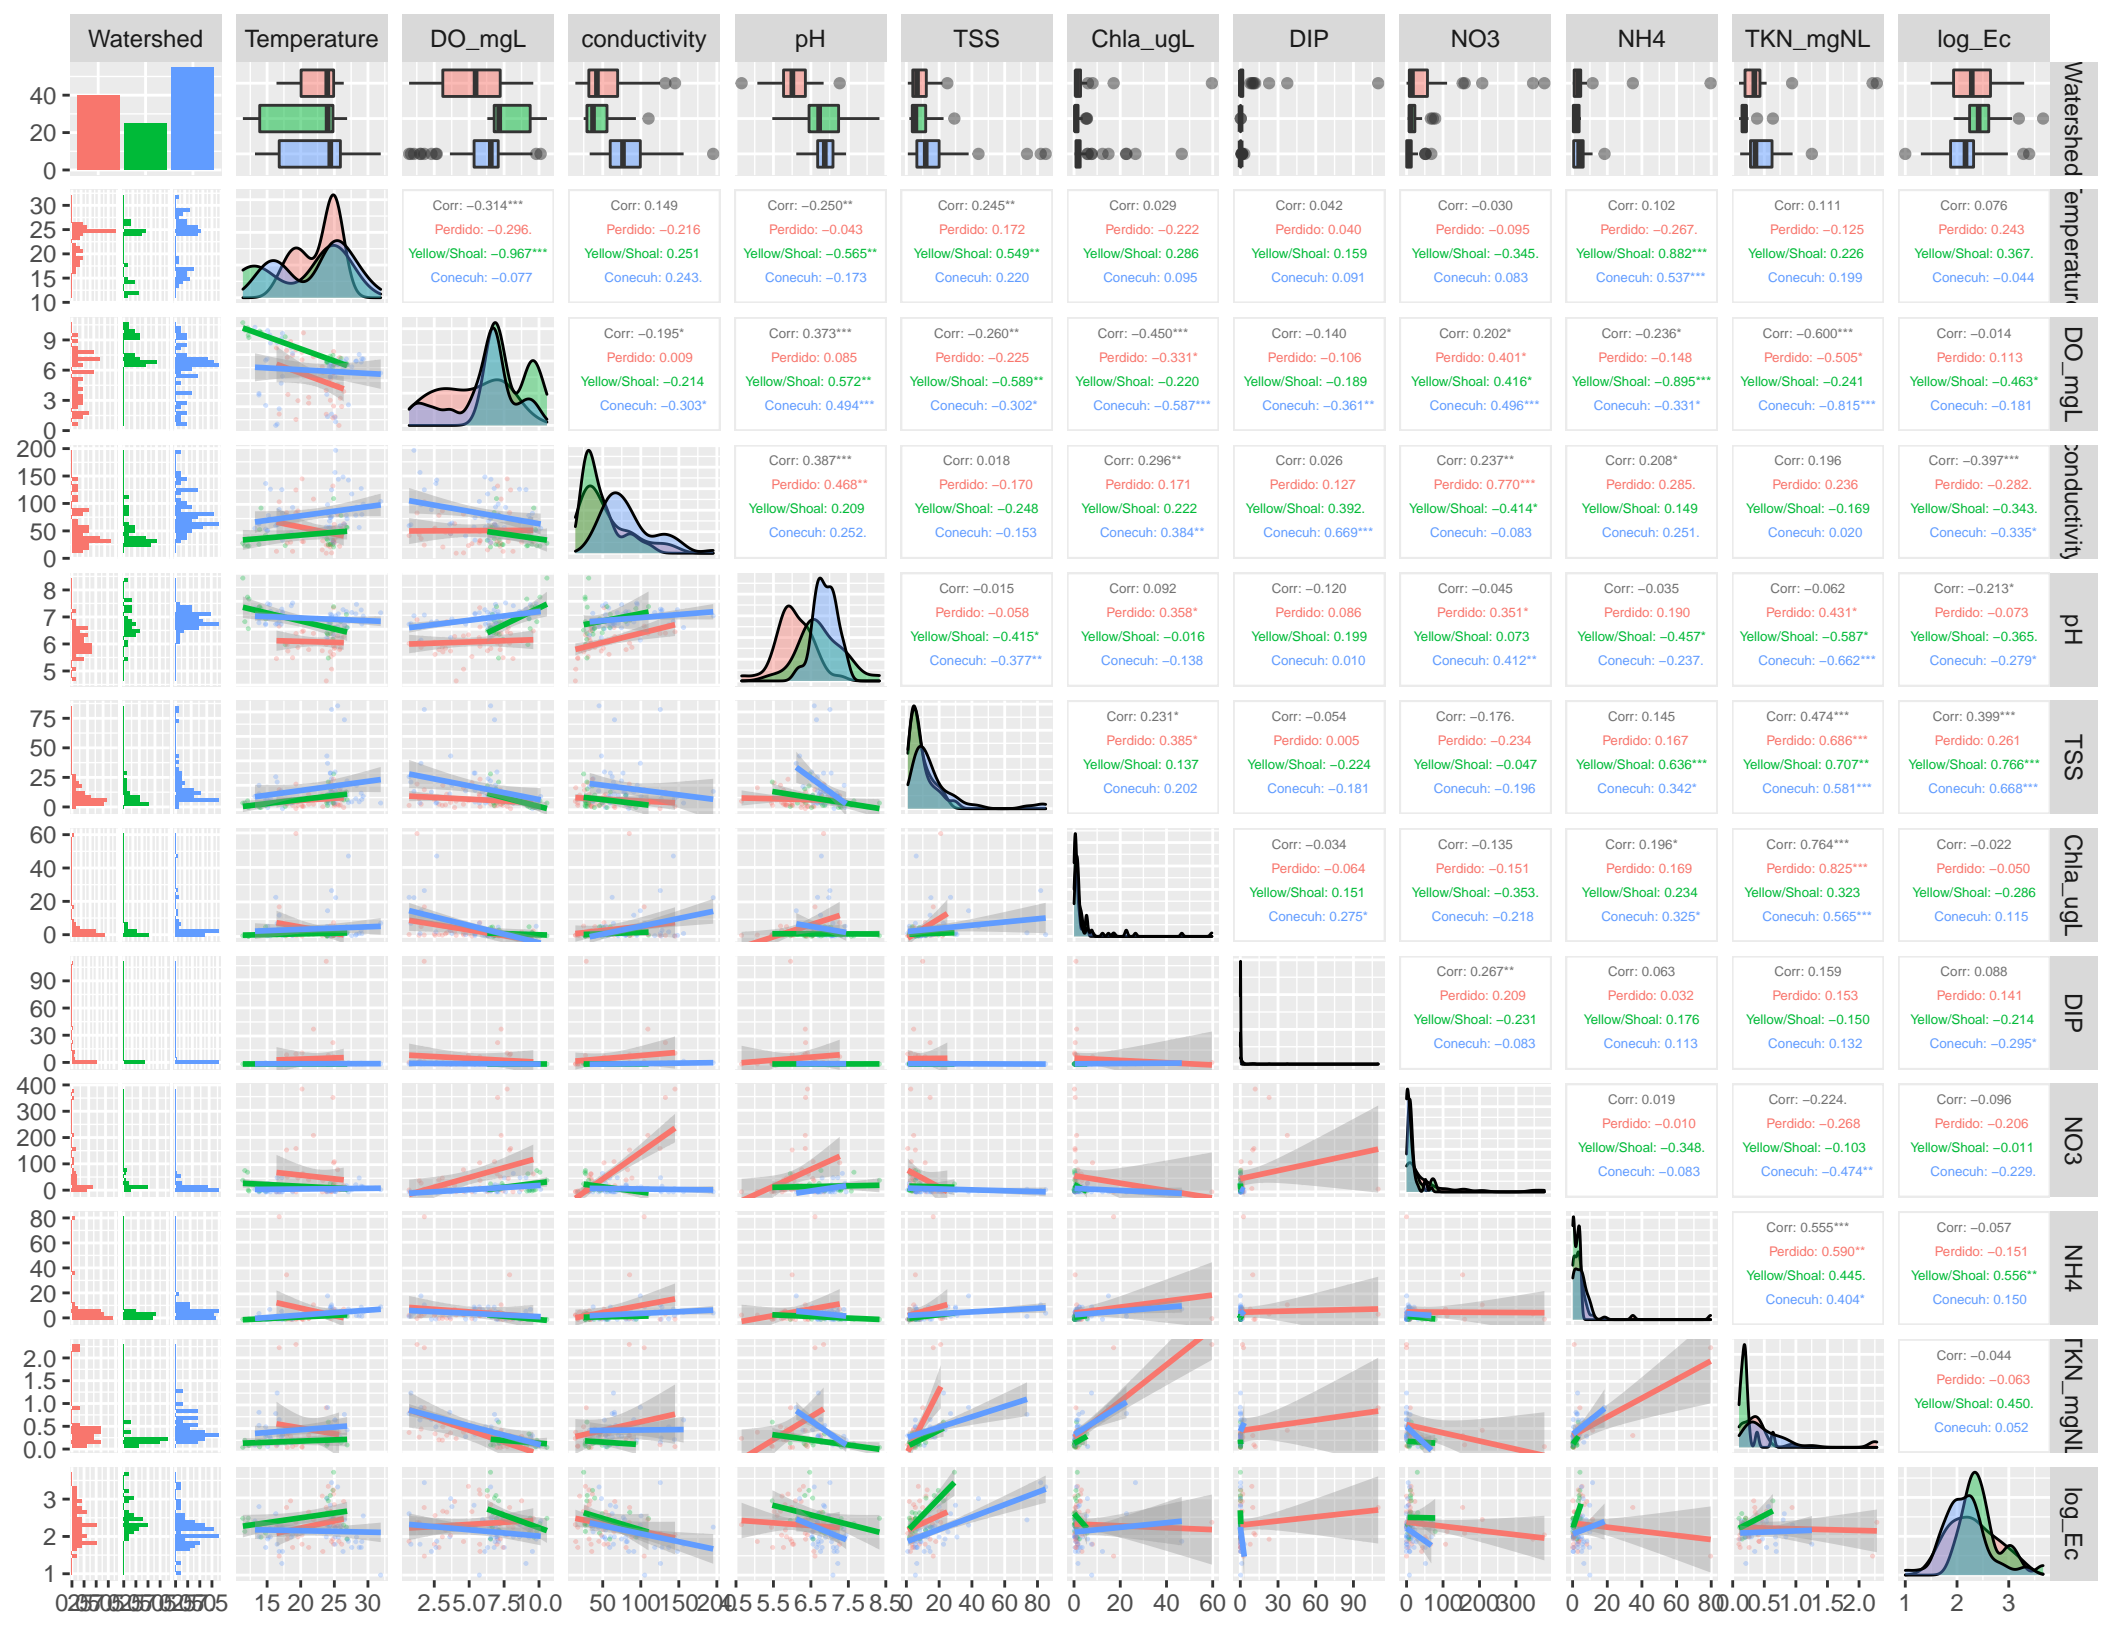
Supplemental Figure 1 – Correlation matrix of environmental parameters: temperature (°C), Dissolved Oxygen (DO) (mg/L), conductivity ($\mu\text{S}/\text{mc}$), pH, Total Suspended Solids (TSS) (mg/L), Chlorophyll a (Chla) ($\mu\text{g}/\text{L}$), Dissolved inorganic phosphate (DIP) (μM), Nitrate+nitrite (NO_3) (μM), Ammonium (NH_4) (μM), Total Kjeldahl Nitrogen (TKN) (mg N/L), and the log of *E. coli* (MPN/100 mL). Pearson correlation coefficients are reported in top right for all values (black), Perdido Watershed values (red), Yellow/Shoal Watershed values (green) and Conecuh Watershed values (blue). Significance level at 0.05 represented by *, at 0.01 by ** and at 0.001 by ***. Distributions of values are shown in diagonal cells and leftmost column. Best fit correlation line is shown in bottom left.

Dissolved oxygen concentrations ranged from less than 1 mg/L to 10.6 mg/L (Figure 4). Concentrations were generally higher during the cooler months (Supplemental Figure 1). In contrast, dissolved oxygen in the Eglin AFB streams averaged 8.32 and had a range from 6.68 to 8.94 (Thom, 2005). While there was a negative correlation between dissolved oxygen and temperature at all sites ($r=-0.31$, $p<0.001$), this relationship was driven by the Yellow/Shoal sites ($r=-0.97$, $p<0.001$), which also had the overall highest dissolved oxygen values. This was not solely driven by the relationship between temperature and concentration, since dissolved percent saturation and temperature were also correlated ($r=-0.75$, $p<0.001$). Perdido Creek and Conecuh River E had multiple values less than 3 mg/L. Occasional low values also occurred at several locations in the Conecuh and Perdido watersheds, with some low values occurring in November at Log and Manning Creeks. Dissolved oxygen criteria for freshwater is 5 mg/L for early life stages and sensitive species and 3 mg/L for warm water systems (U.S. Environmental Protection Agency, 1986). Across the entire dataset (118 samples), 32 samples (27%) had values less than 5 mg/L with 18 samples (15%) having values less than 3 mg/L.
